## Inspection Report

Property Address:

**Allegiance Inspections LLC**

<b>Date:</b> 4/11/2019	<b>Time:</b> 09:45 AM	<b>Report ID:</b> 041119-edisto
<b>Property:</b> [REDACTED]	<b>Customer:</b> [REDACTED]	<b>Real Estate Professional:</b> [REDACTED]

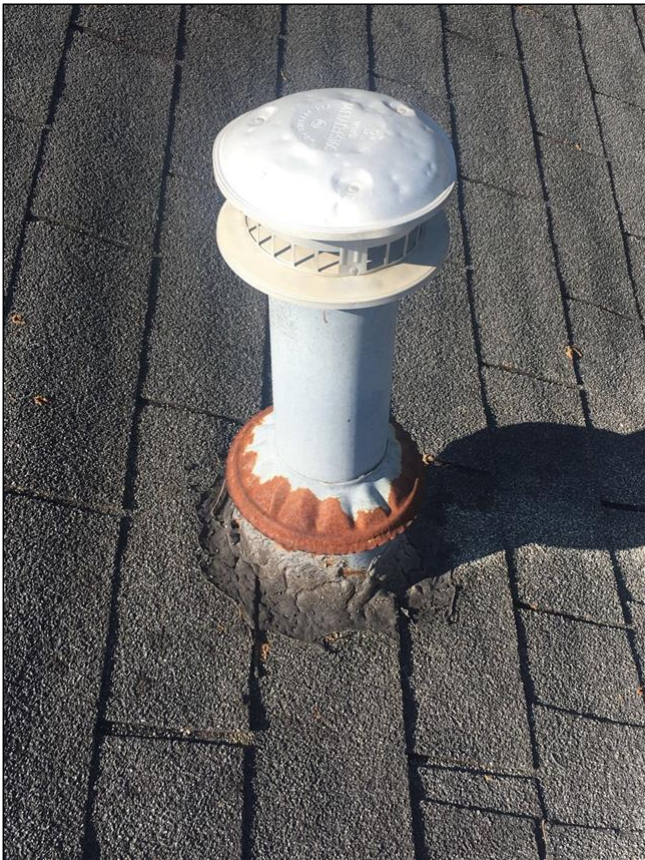
Metal flue - roofside

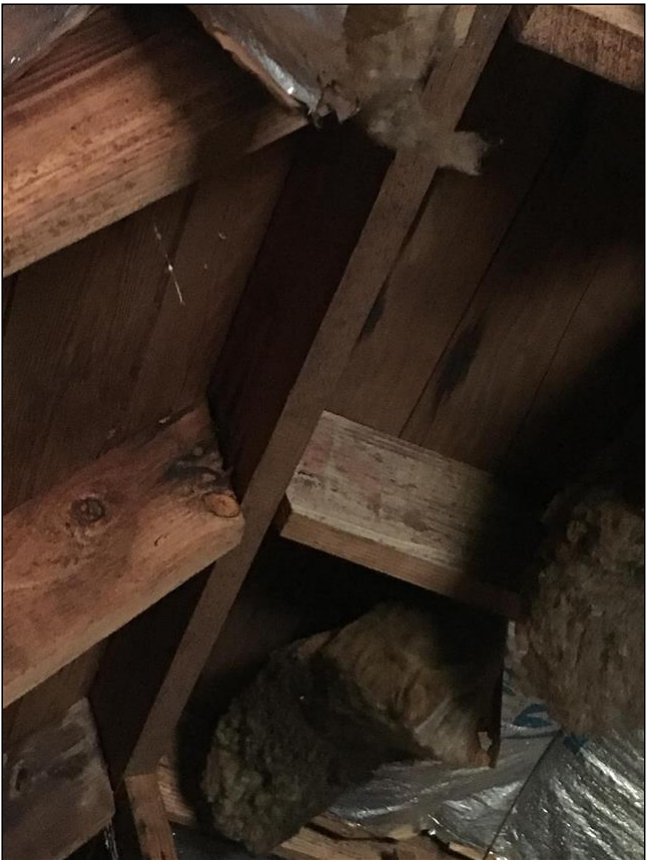
Rafters roof system

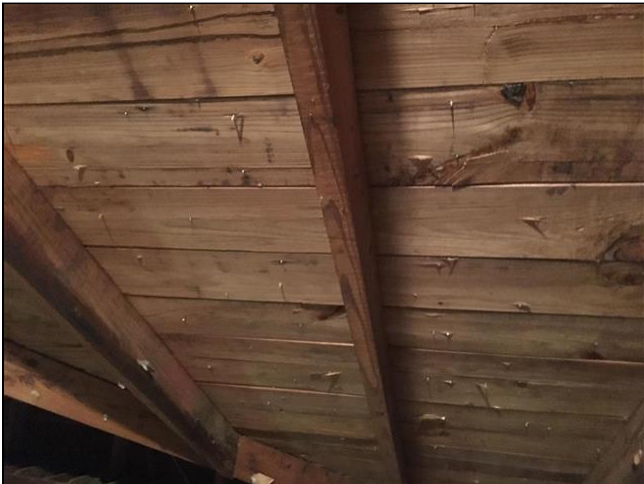
Plywood sheathing

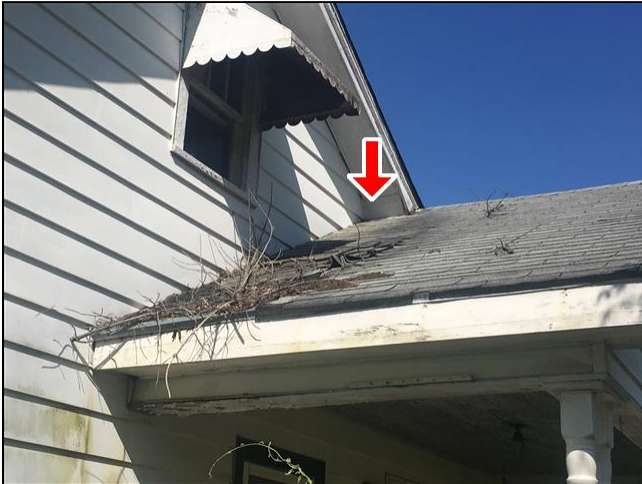
1.0 Item 3(Picture)

1.0 (2) Shingles have holes, missing, damaged, blistering , loose. It appears roof has **reached the end of its useful life;**  
**recommend roof replaced by a qualified professional roofing contractor**

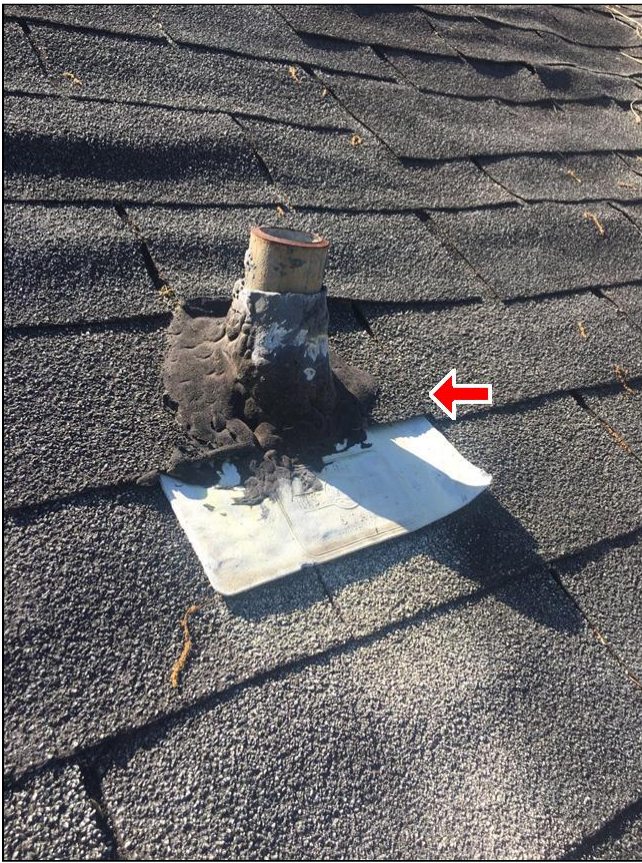
1.1 Item 2(Picture) Illustration of proper plumbing vent installation

1.1 (1) Improper flashing at plumbing vent; recommend replacing by qualified professional roofer

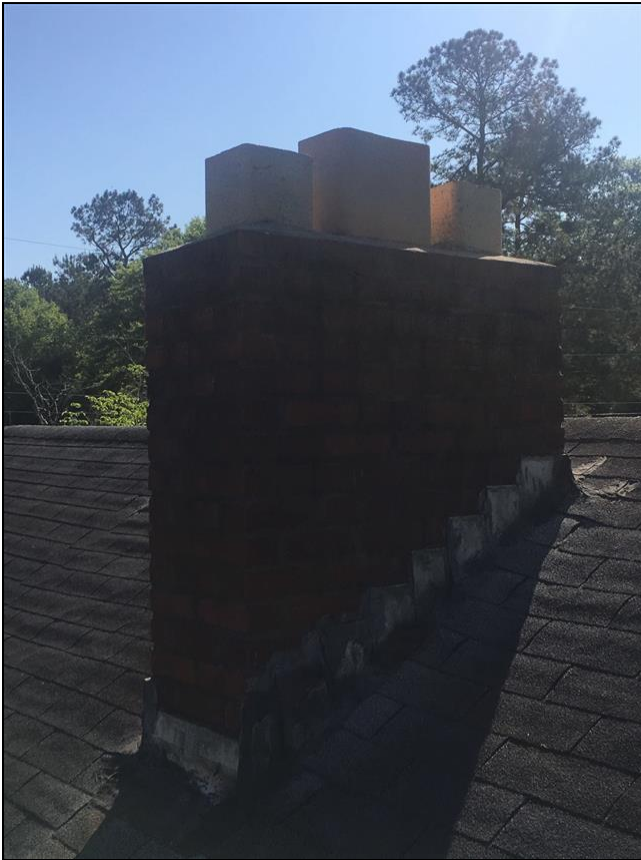
Step flashing on exterior chimney chase sealed with apparent roof tar; recommend monitoring and repair when necessary

1.2 Item 1(Picture) Exterior chimney chase

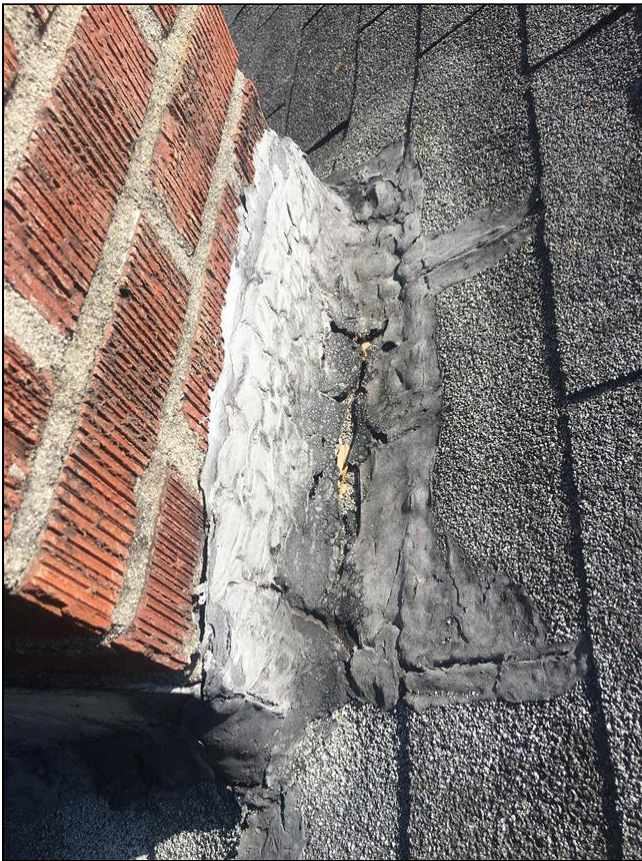
1.2 Item 3(Picture)

Apparent moisture stains on sheathing near interior chimney chase in attic

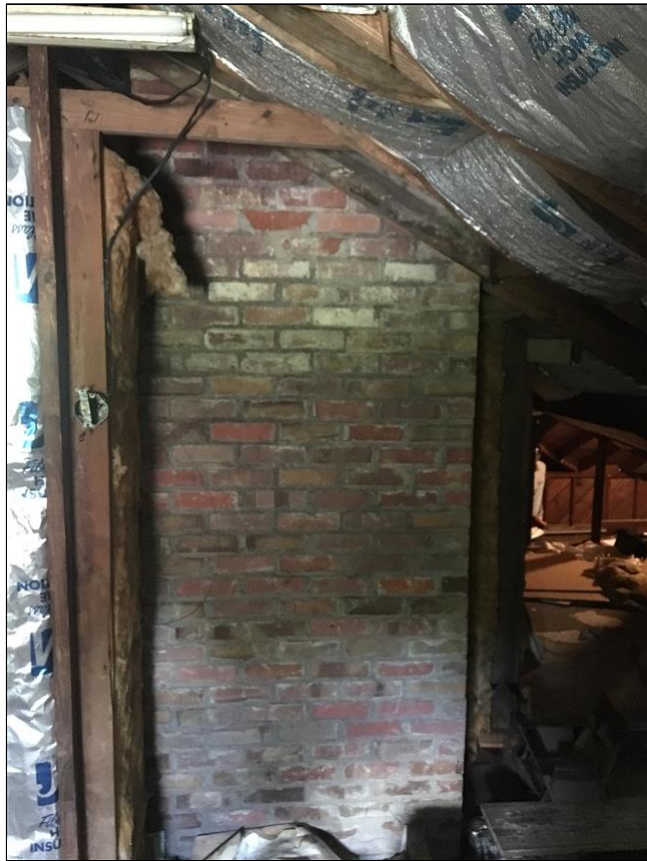
1.2 (1) Item 4(Picture) Recommend rain cap/spark arrestor on chimney chase

1.2 Item 4(Picture) Chimney chase in attic

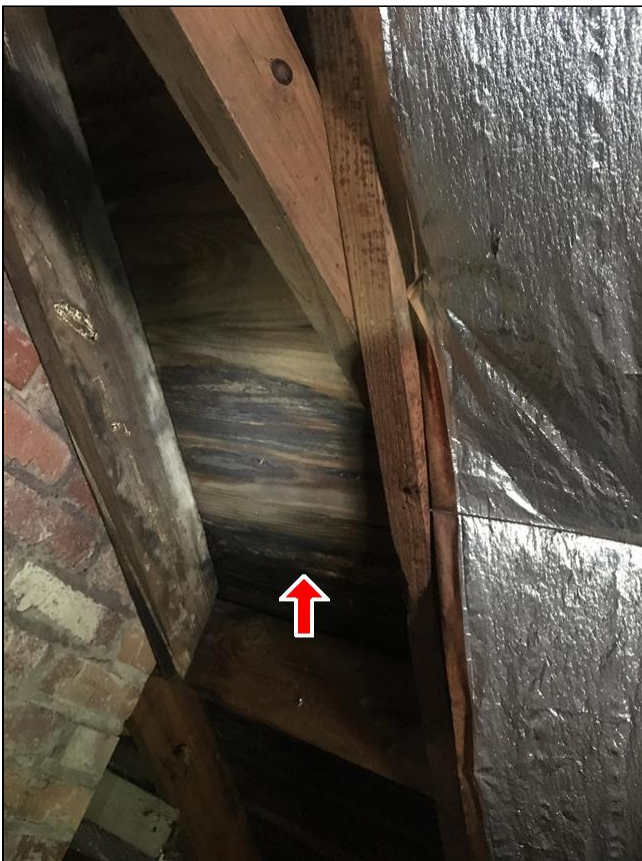
1.2 Item 5(Picture) Moisture stain near chimney chase in attic

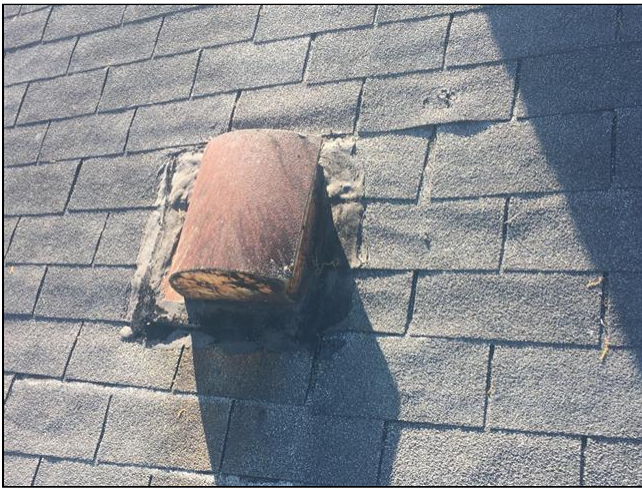
1.2 Item 6(Picture)

1.2 (2) Roof vent rusted; recommend replacement by qualified professional contractor

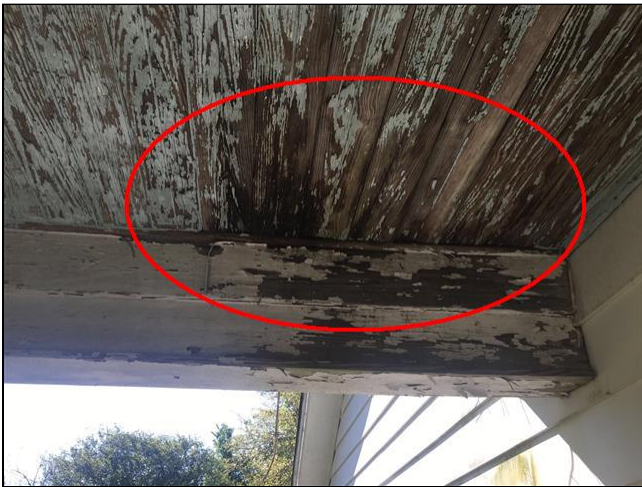
1.5 Item 1(Picture)

1.5 (1) Soft wood/wood rot on exterior ceiling of front entry area; moisture meter readings: 22.8%, 23.8%, 48.3%; the maximum acceptable moisture percentage for wood is 20%. Recommend replacing damaged areas as applicable

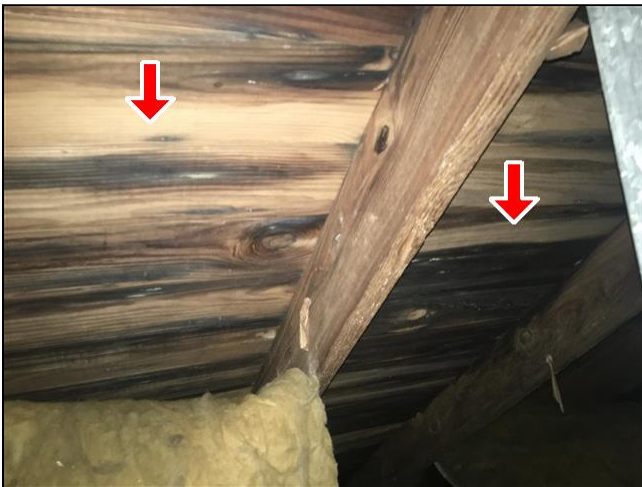
1.5 Item 5(Picture)

1.5 (2) Moisture stains on sheathing in attic; recommend evaluation by qualified professional roofer and repair or replace as necessary

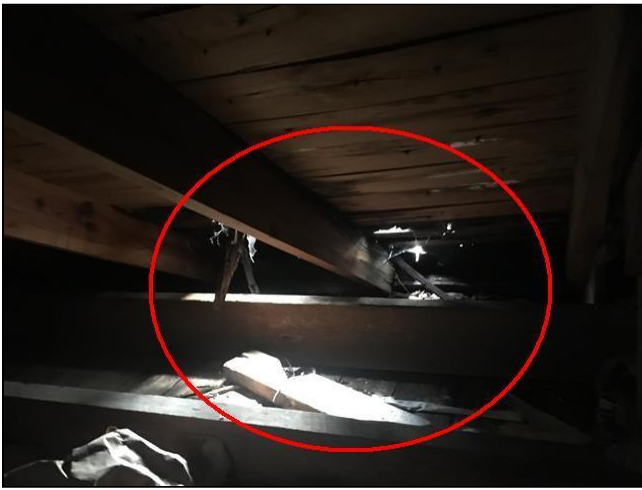
1.5 Item 6(Picture)

**1.5 (3) Hole in roof deck; recommend repair by qualified professional roofer**

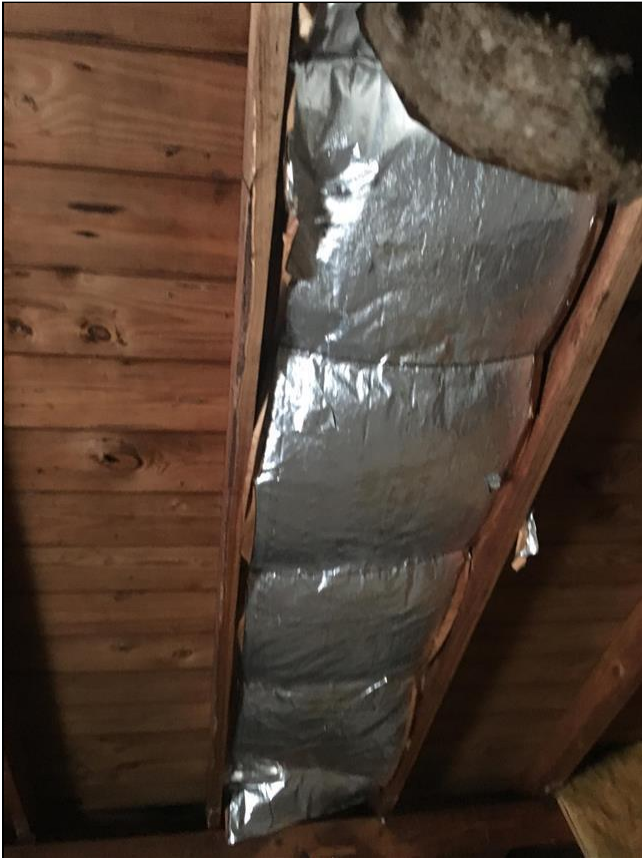
1.7 Item 1(Picture)

**1.7 Insulation failing throughout attic area; apparent install on underside of roof deck; recommend repair by qualified contractor**

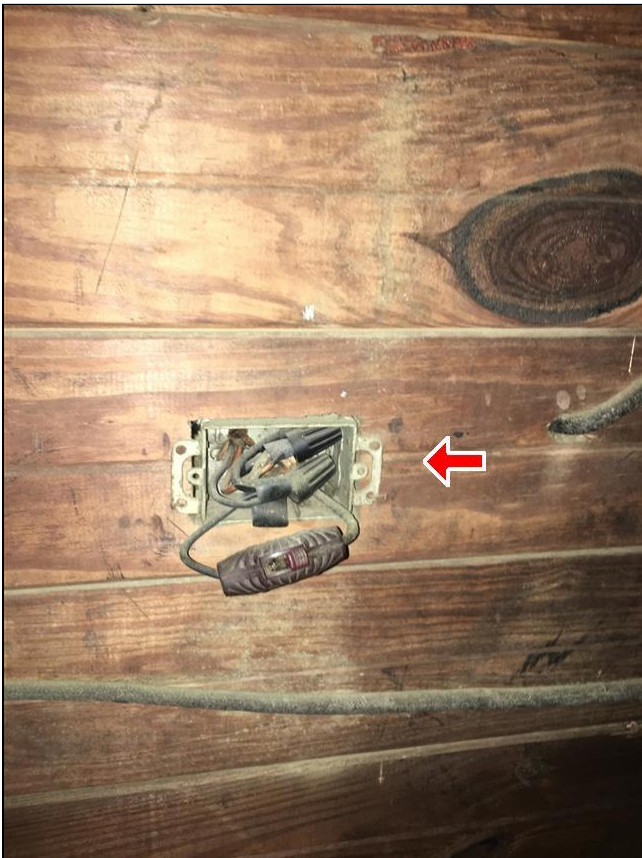
1.8 Item 1(Picture)

1.8 Open junction boxes in attic; recommend repair or replace all open junction boxes, loose wires as applicable

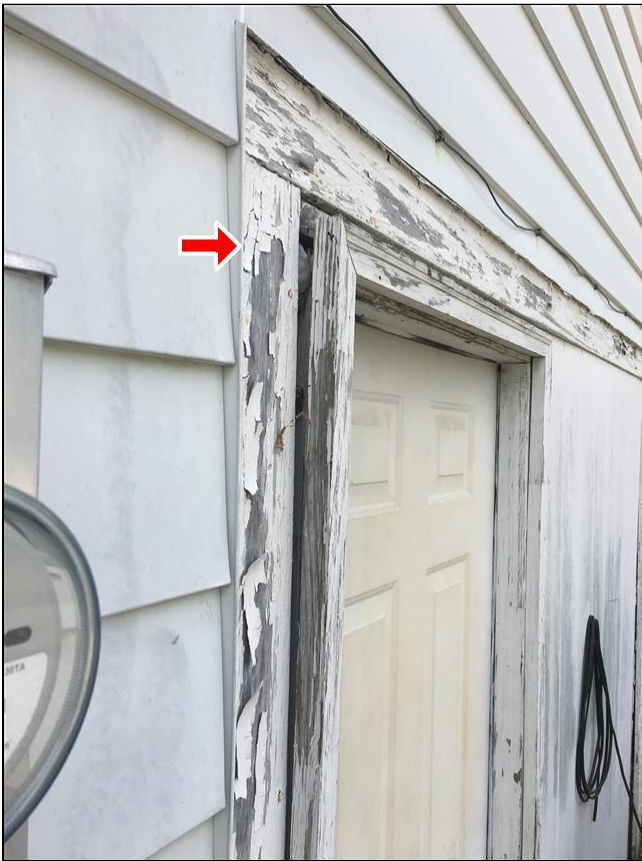
2.1 Item 1(Picture)

**2.1 Door frame detached from casing; recommend repair**

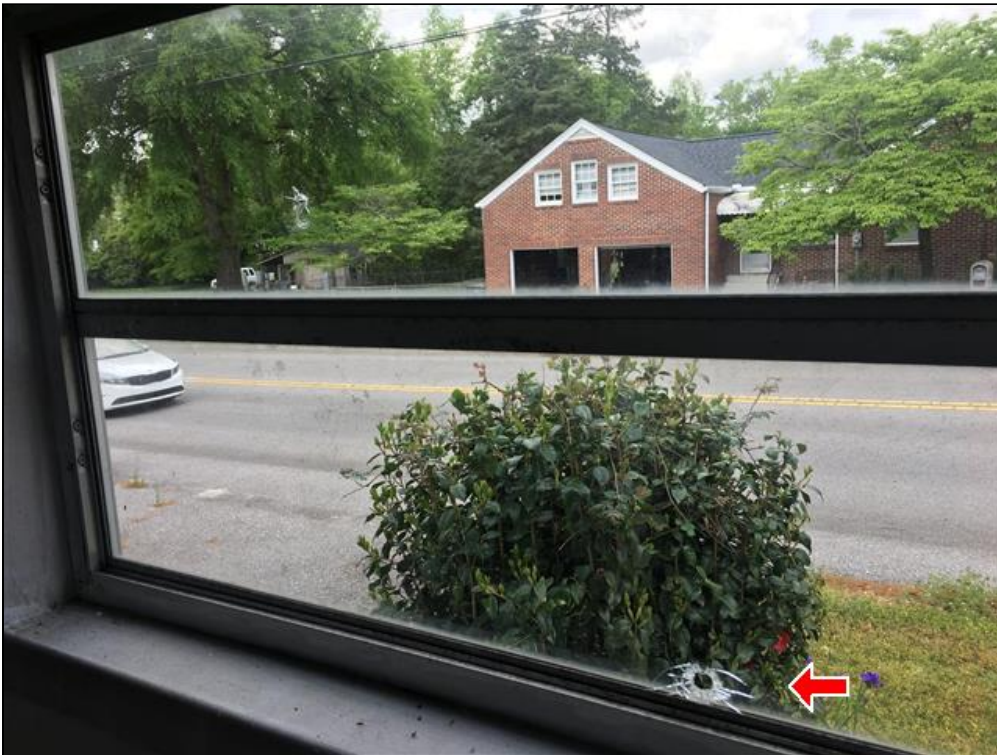
2.2 Item 2(Picture)

**2.2 (1) Multiple windows with holes, cracked glass. damage; recommend replacing**

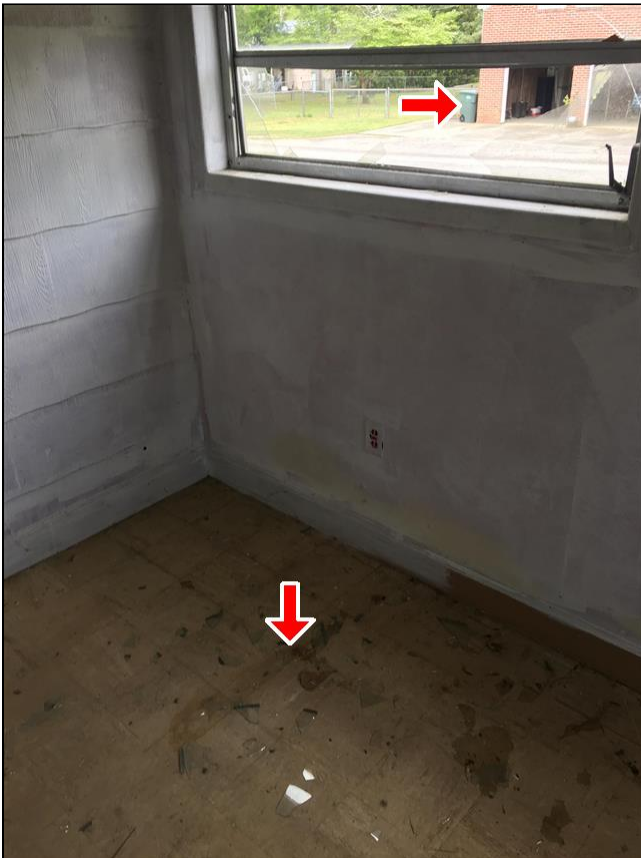
2.2 Item 3(Picture) Glass broken/shattered - on floor

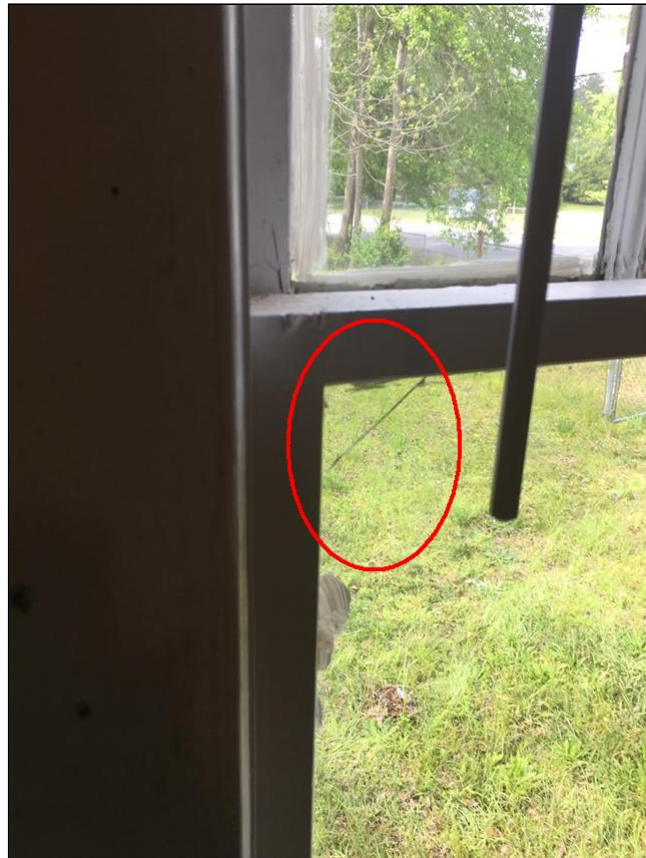
2.2 Item 4(Picture) Cracked window glaze

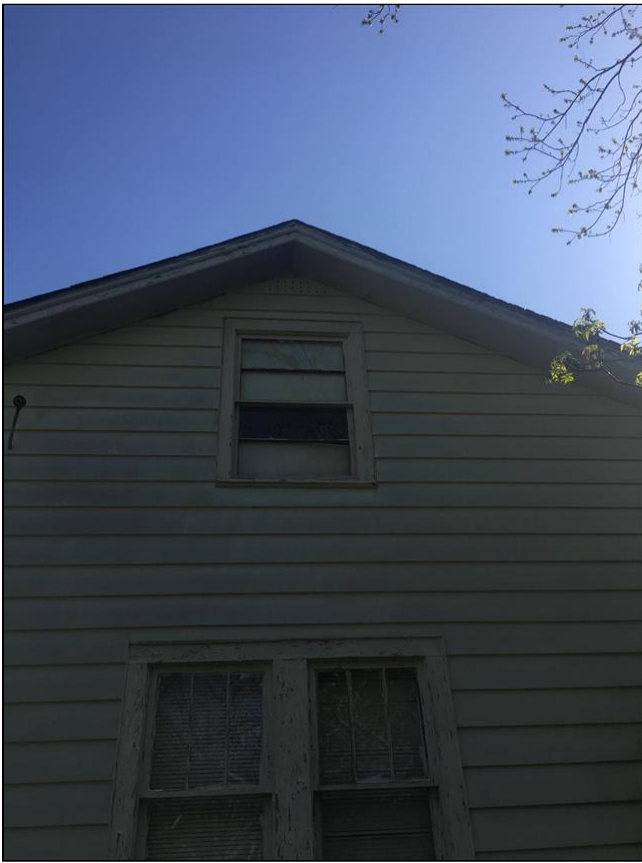
2.2 (2) Multiple windows missing; recommend installing

2.2 Item 5(Picture) Exterior view of missing window

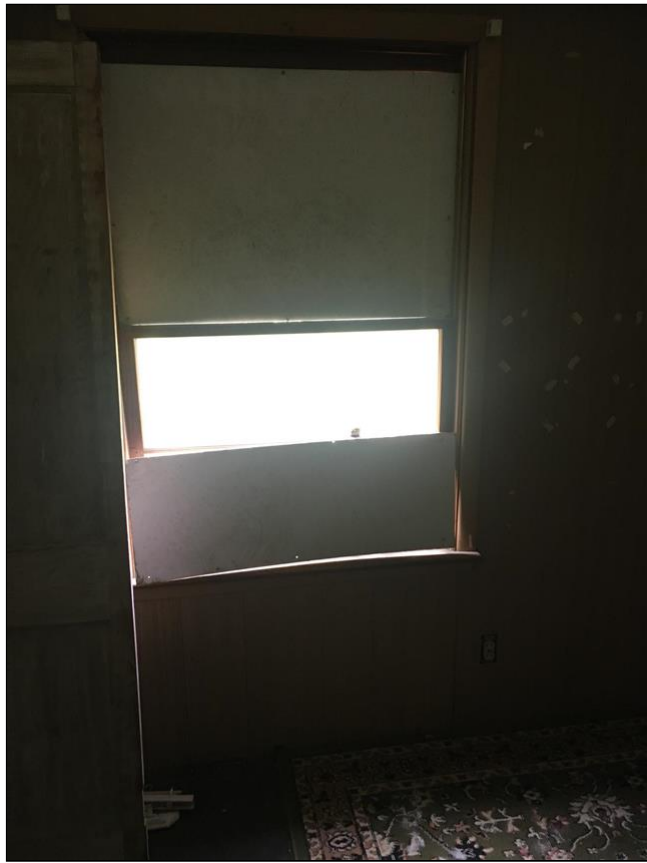
2.2 Item 6(Picture) Window missing

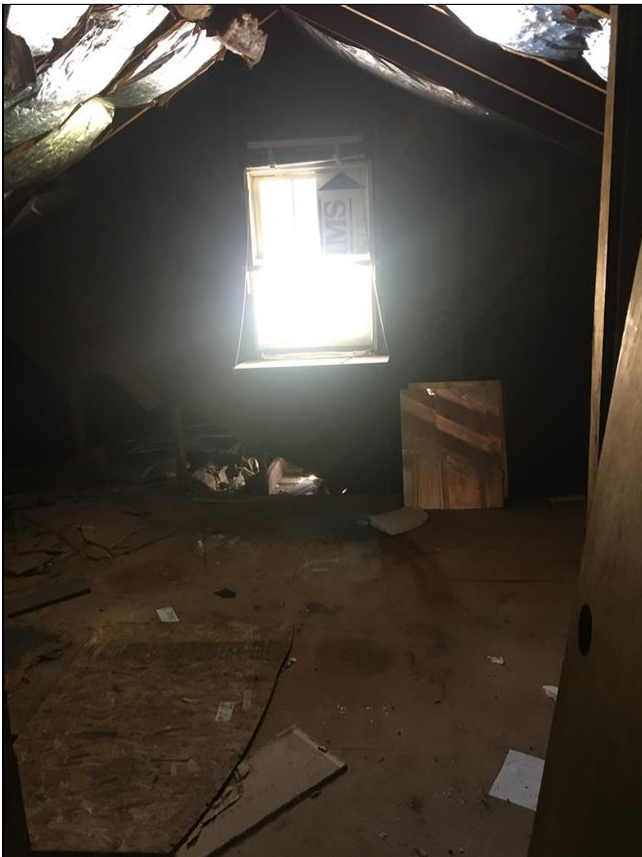
2.2 Item 7(Picture) Damaged window in attic

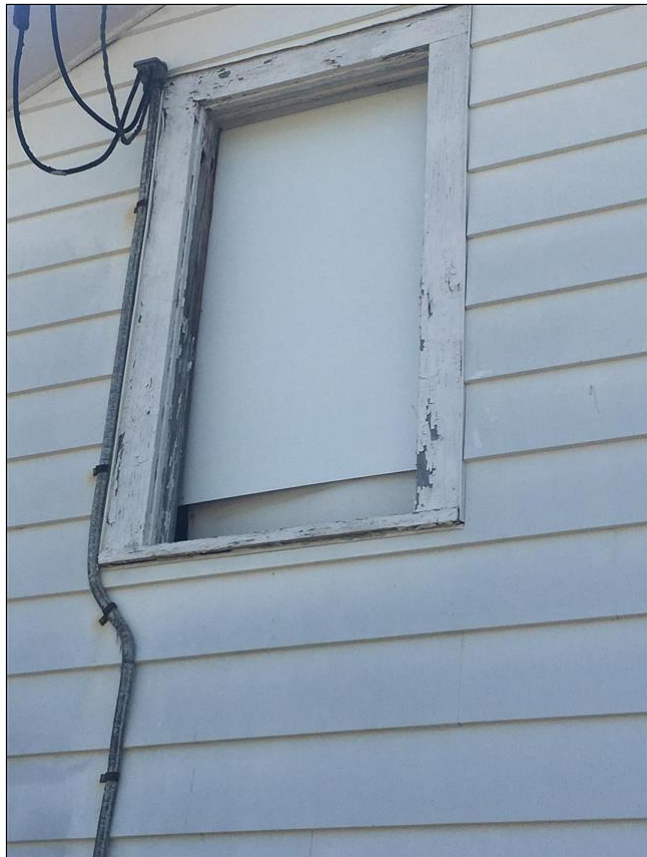
2.2 Item 8(Picture) Window missing

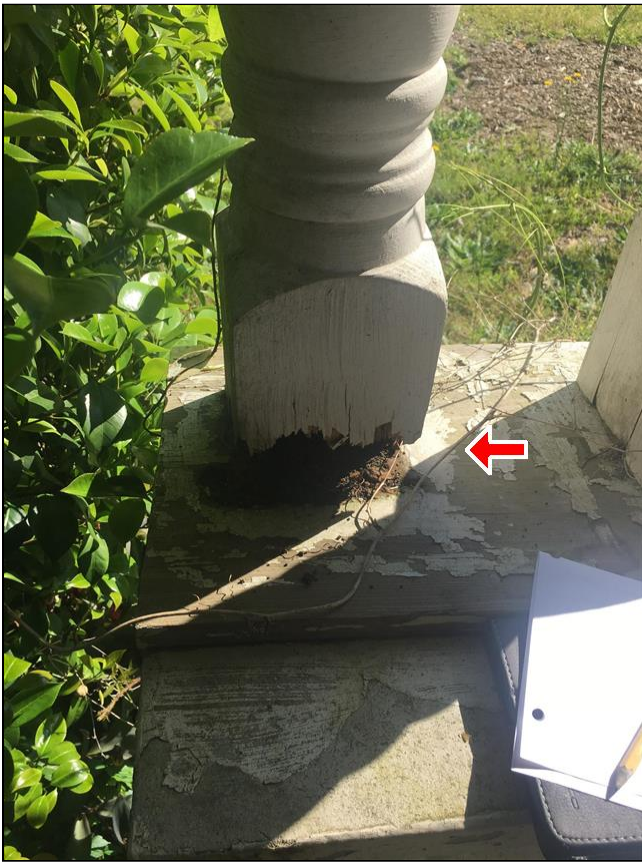
2.3 Item 1(Picture)

2.3 Wood support post damaged/wood rot; recommend replacing

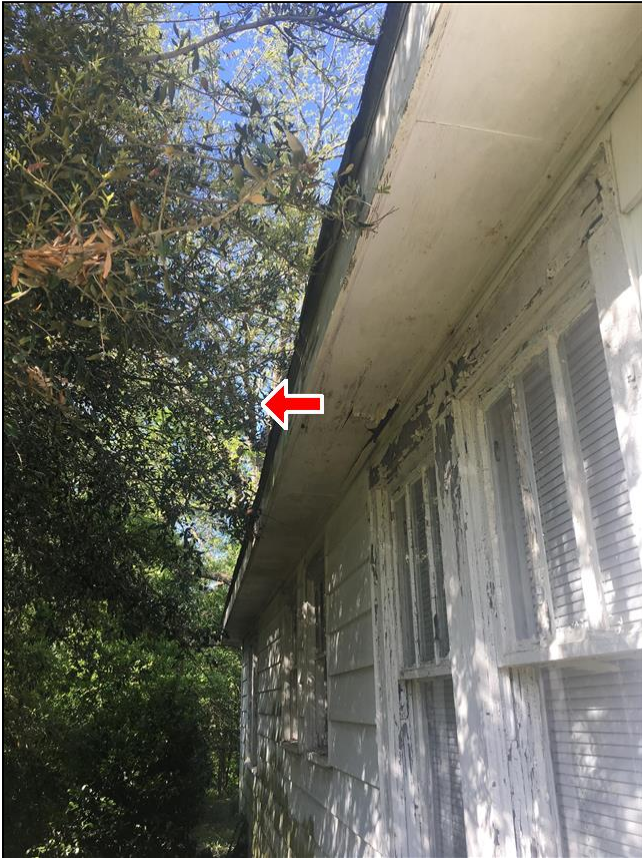
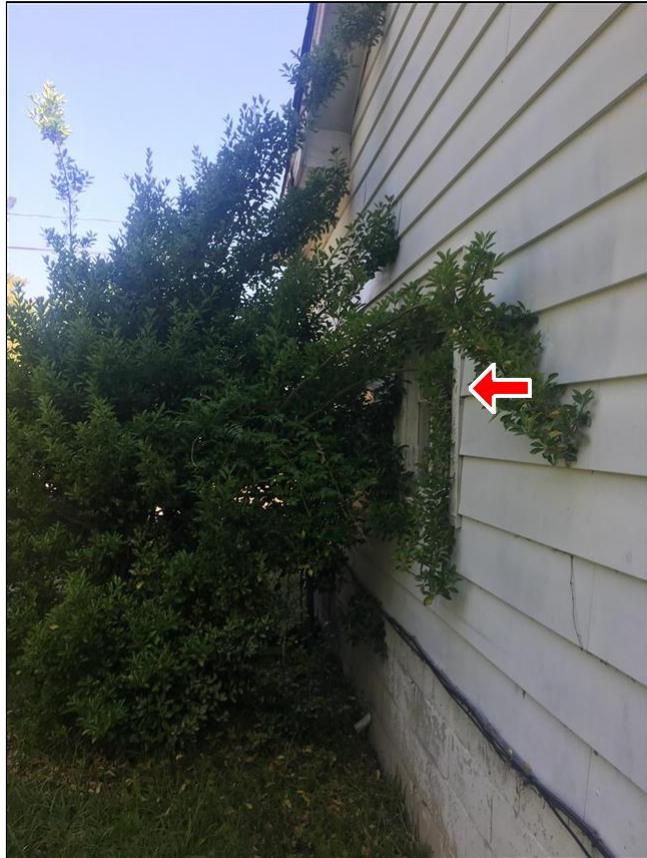
**2.4** The tree limbs that are in contact with roof and siding or hanging near roof and siding should be trimmed to at least 6 inches away from siding; clear from roofline.

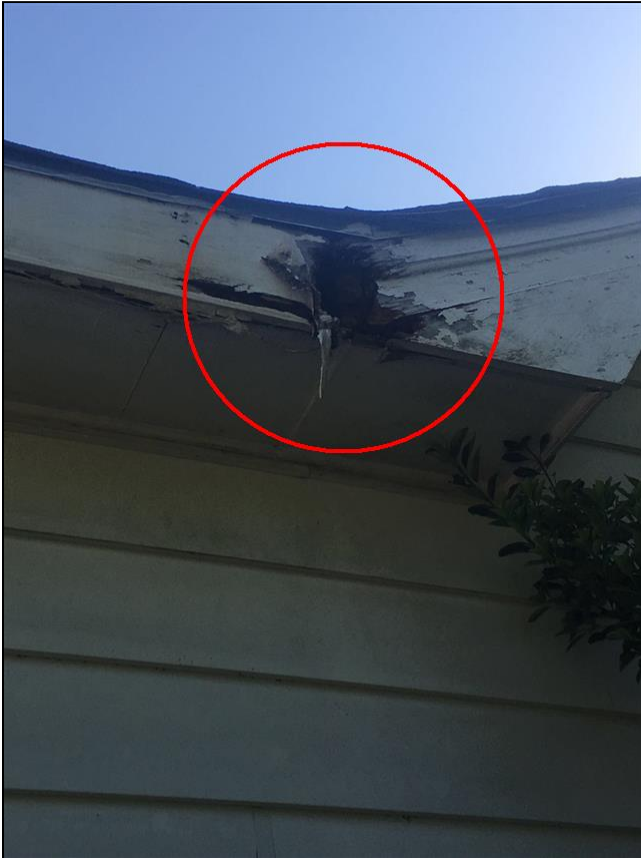
2.5 Item 1(Picture)

**2.5** Fascia damaged; open areas in the exterior roof system are prone to water and pest intrusion which can cause damage; recommend repair

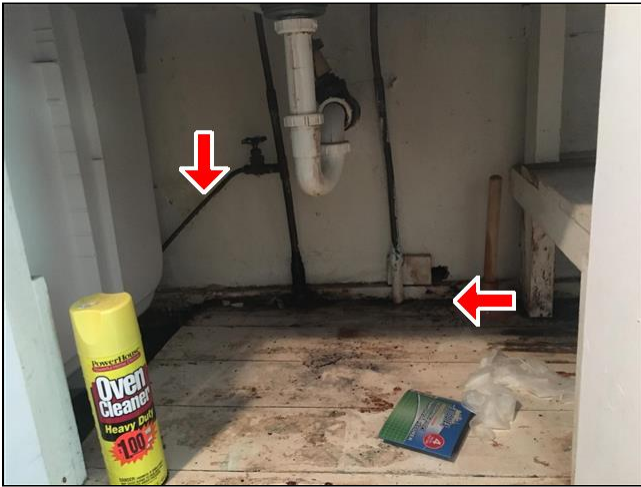
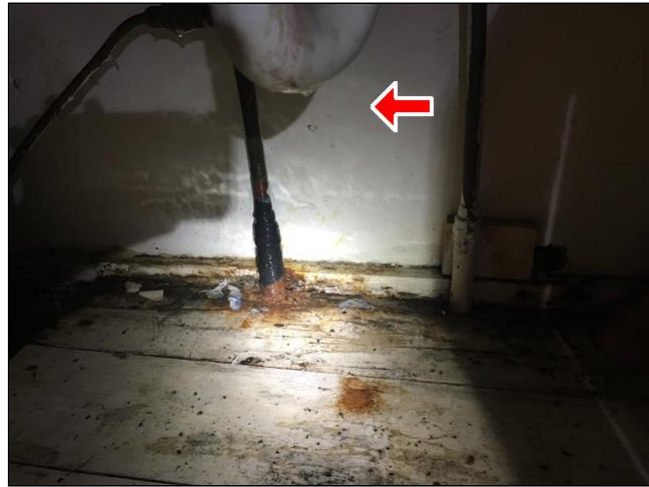
4.6 Active water leak under kitchen sink; Repairs are needed to stop leaking water from damaging the cabinet bottom or to eliminate moisture that may contribute to fungi growth. A qualified licensed plumber should repair or correct as needed.

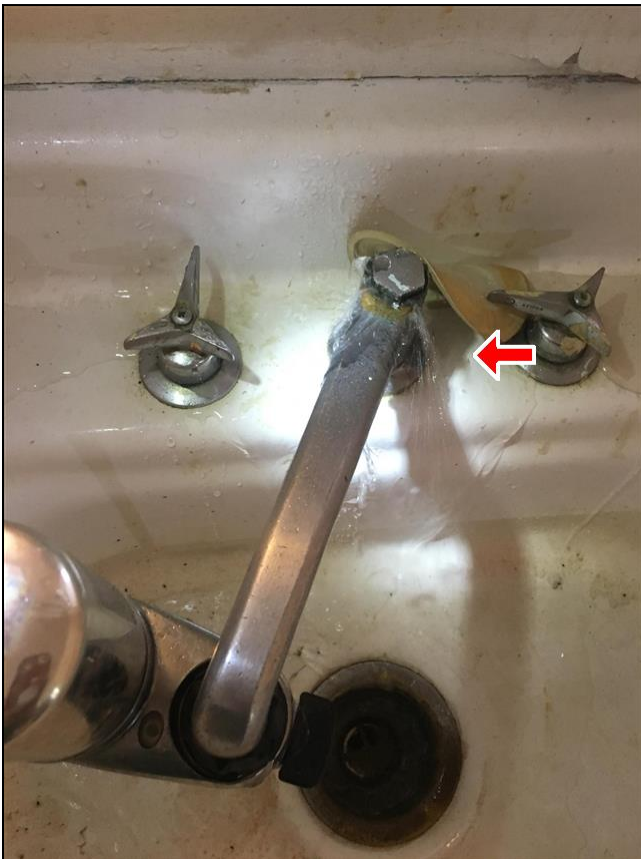
4.7 Item 1(Picture)

4.7 The lever on faucet leaks at the kitchen sink. I recommend repair as necessary by a qualified person.

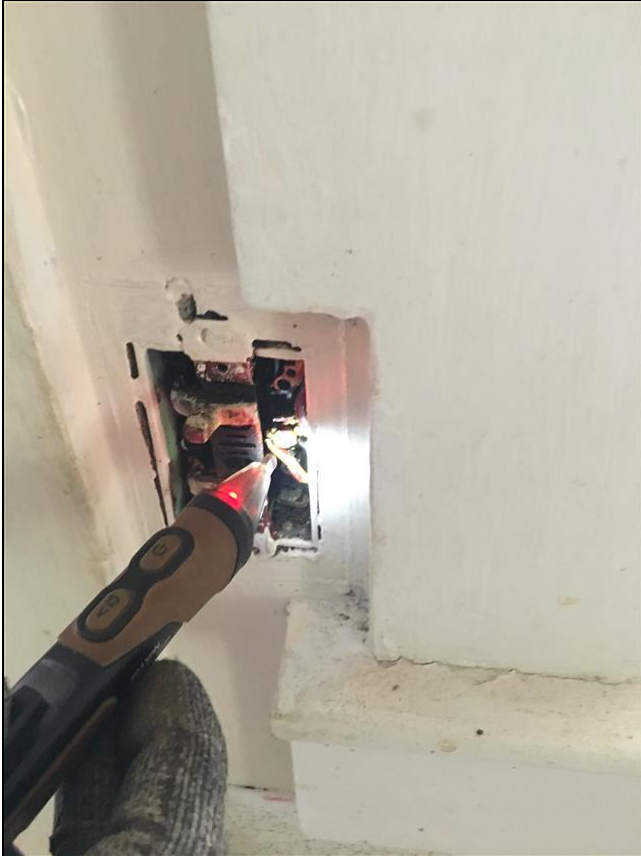
4.8 Item 1(Picture)

**4.8** Switch missing protective cover with active wires present; this receptacle is located within 6 feet of a water source (kitchen sink); this is a safety hazard; recommend repair by licensed electrician

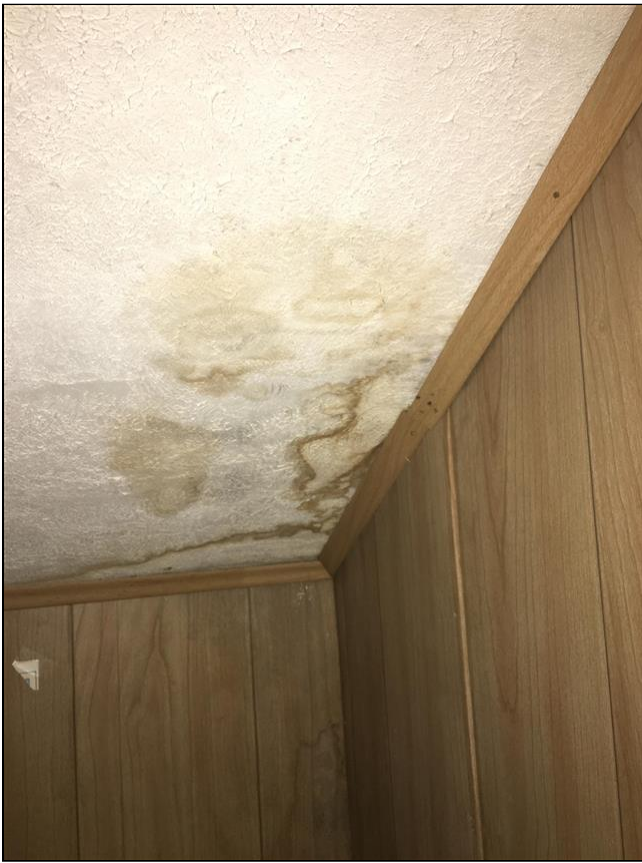
5.0 Item 1(Picture)

**5.0 Multiple large moisture stains on ceiling at various rooms in the home; recommend repair after replacing roof**

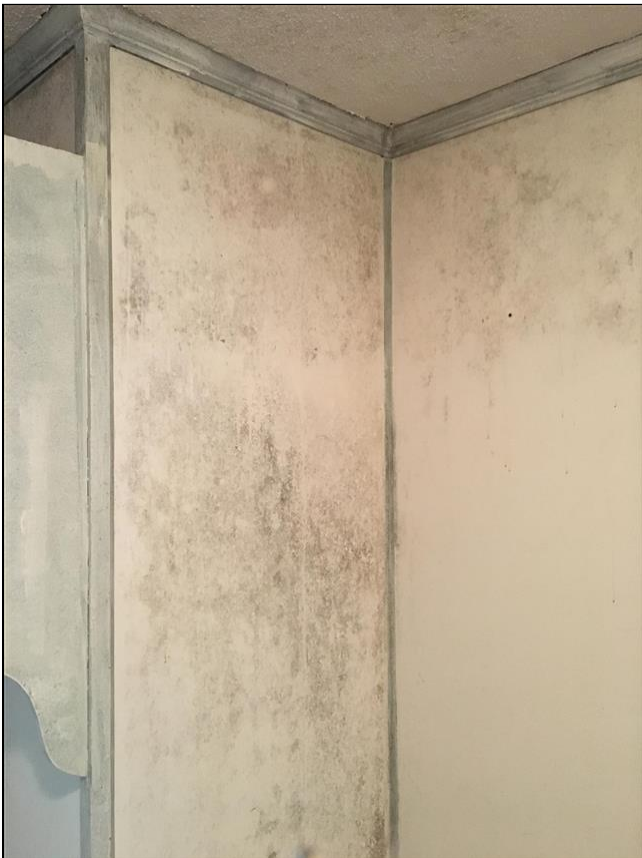
5.1 Item 1(Picture)

5.1 Apparent mold present on walls and door frames in hall area; recommend remediation by qualified person

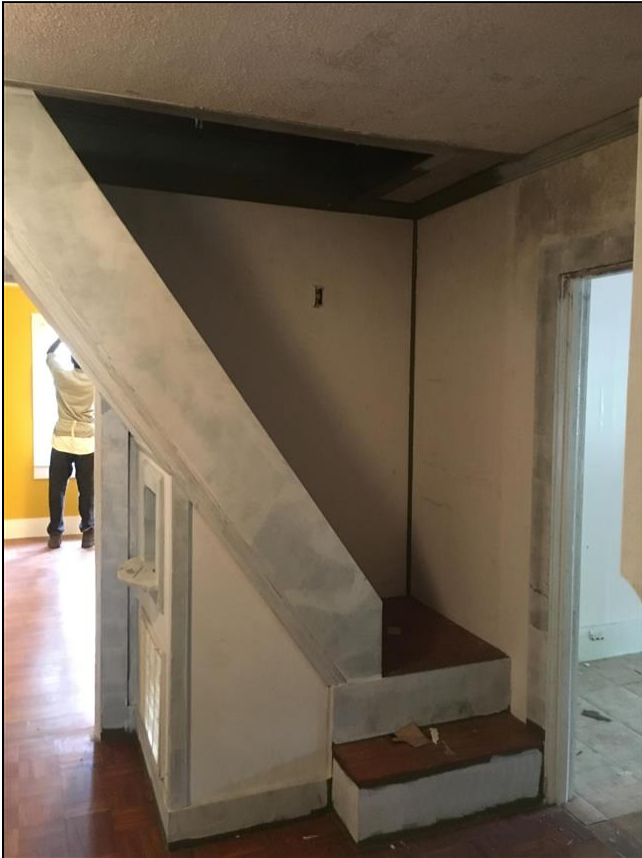
5.3 Item 1(Picture)

5.3 (1) The stair structure is improper. Please refer to the illustration photo for proper installation of the stairwell to meet current standards

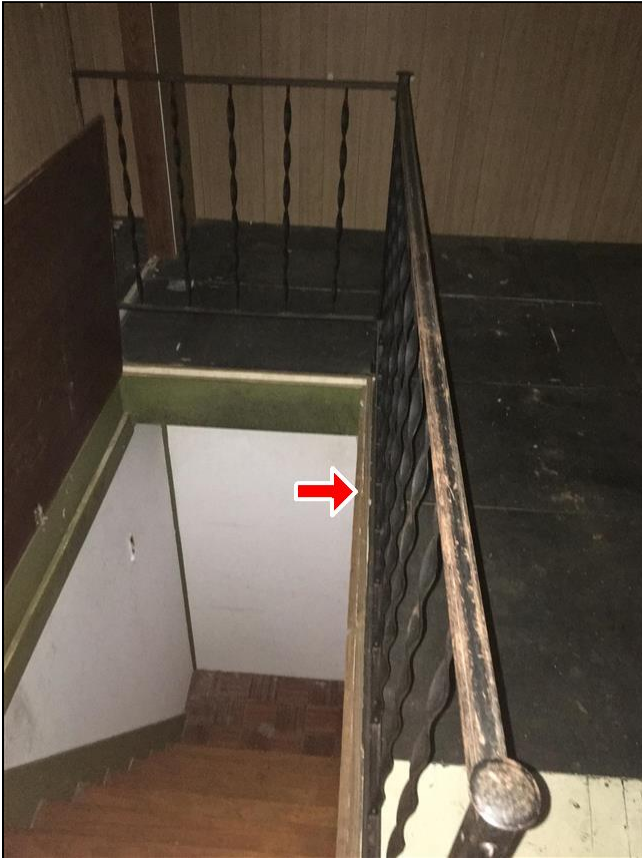
5.3 Item 3(Picture)

**5.3 (2)** The hand/guard rail for the stairs to second level is loose. A fall or injury could occur if not corrected. A qualified contractor should repair or replace as needed.

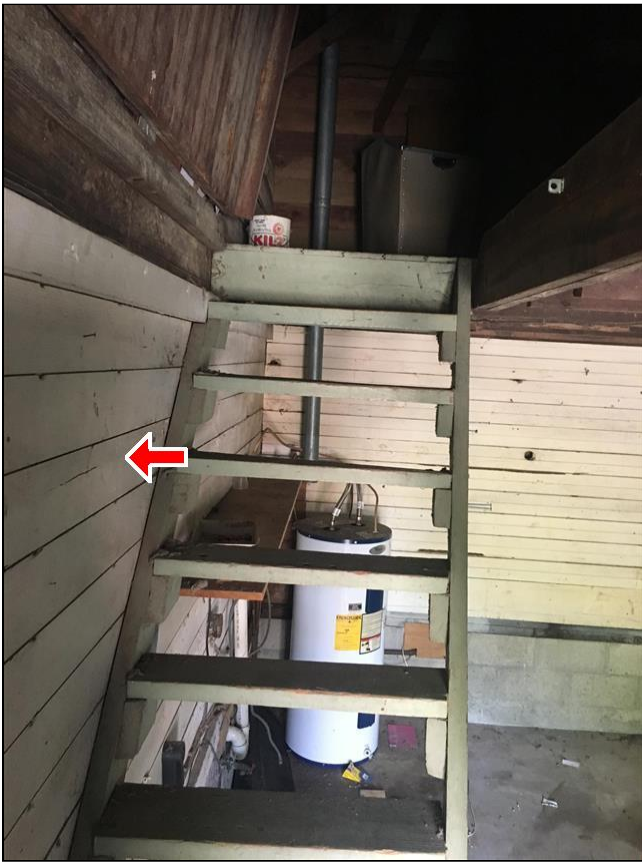
5.3 Item 4(Picture)

5.3 (3) Stairs to attic space has no handrail present; recommend installation by qualified person; this is a safety hazard

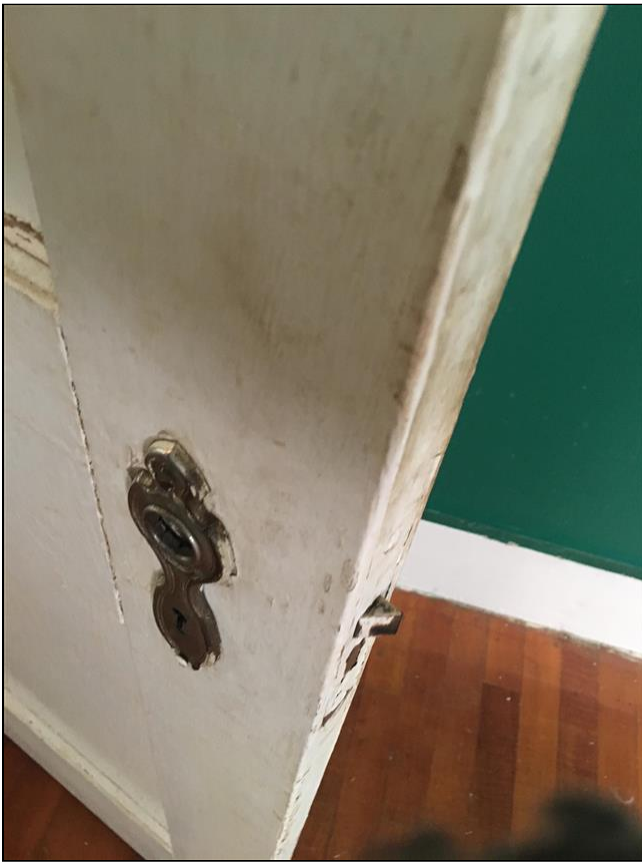
5.4 Item 1(Picture)

**5.4 (1) Multiple doors missing proper hardware (door knobs); recommend repair**

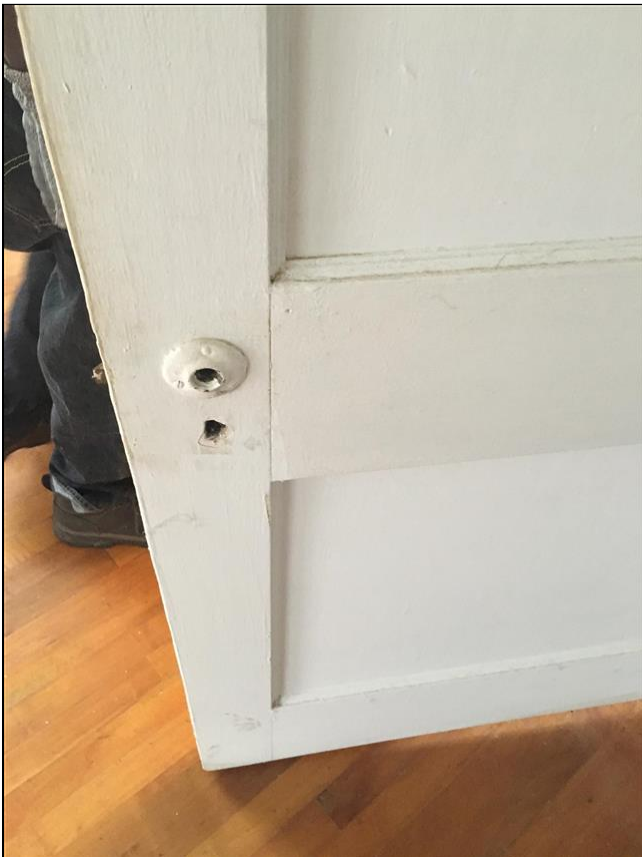
5.4 Item 3(Picture)

**5.4 (2) Bedroom door would not close properly; not aligned with door frame; recommend repair or replace**

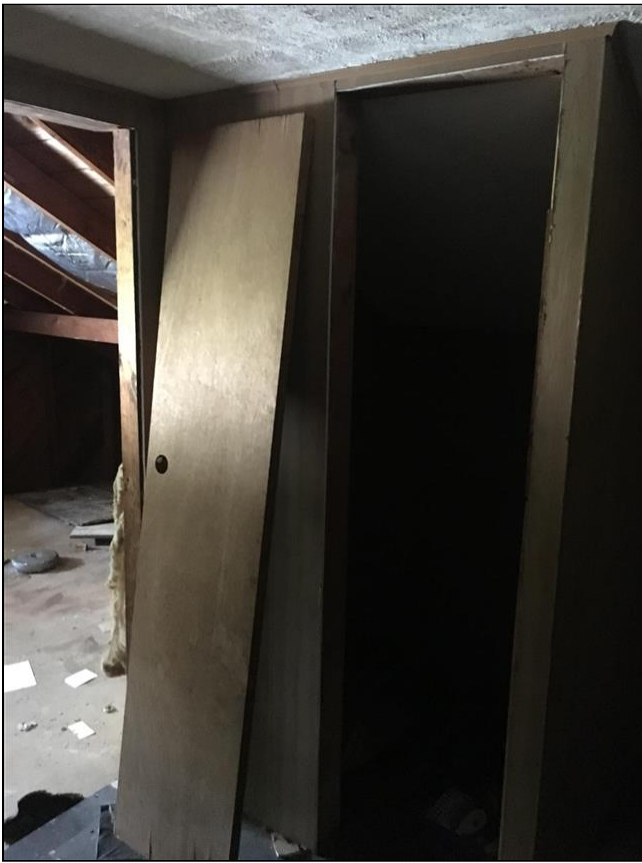
5.4 Item 5(Picture)

5.4 (3) No door separating rooms from attic space; this is a safety concern; recommend installation of doors where needed

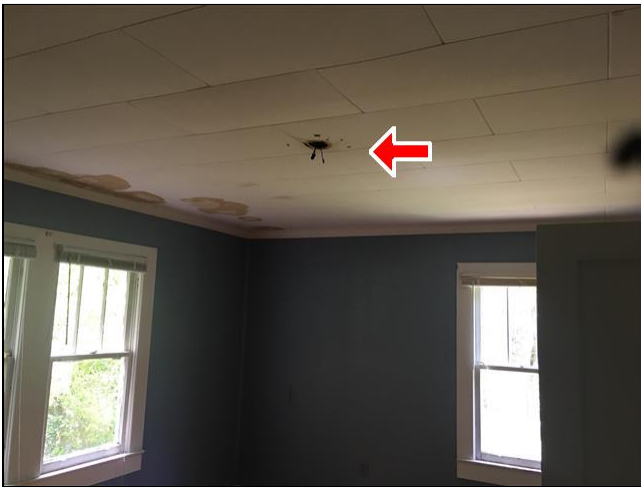
5.6 Item 1(Picture)

**5.6 (1)** Light fixture missing in bedroom; could not test functionality of fixture in second level rooms; recommend repair as necessary

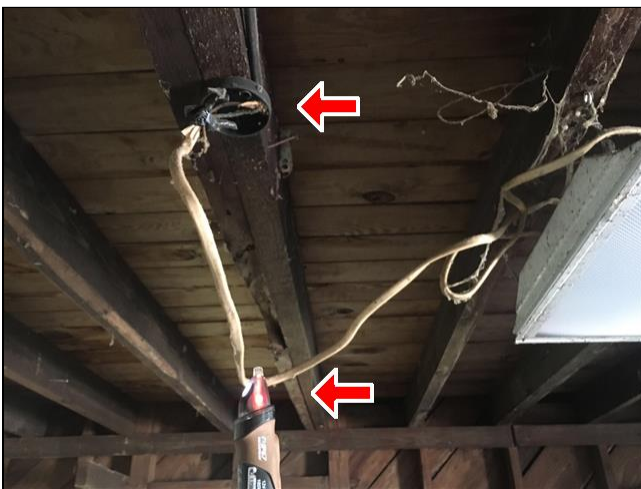
5.6 Item 3(Picture)

**5.6 (2)** Active "hot" wire with no protective junction box in enclosed garage; recommend repair by licensed electrician- this is a safety hazard

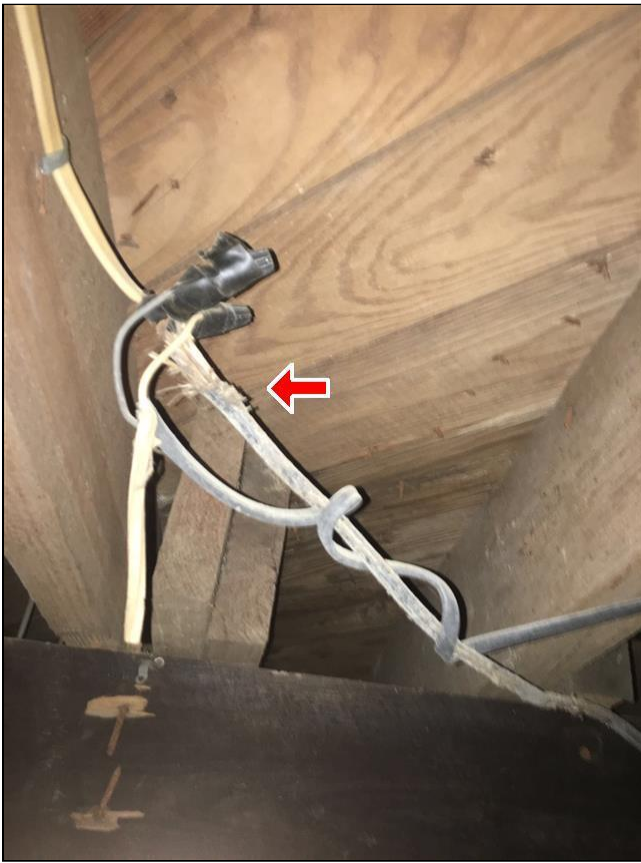
**5.6 Item 4(Picture)**

**5.6 (3) Amateur wiring in crawlspace; recommend installation of junction box by qualified electrician**

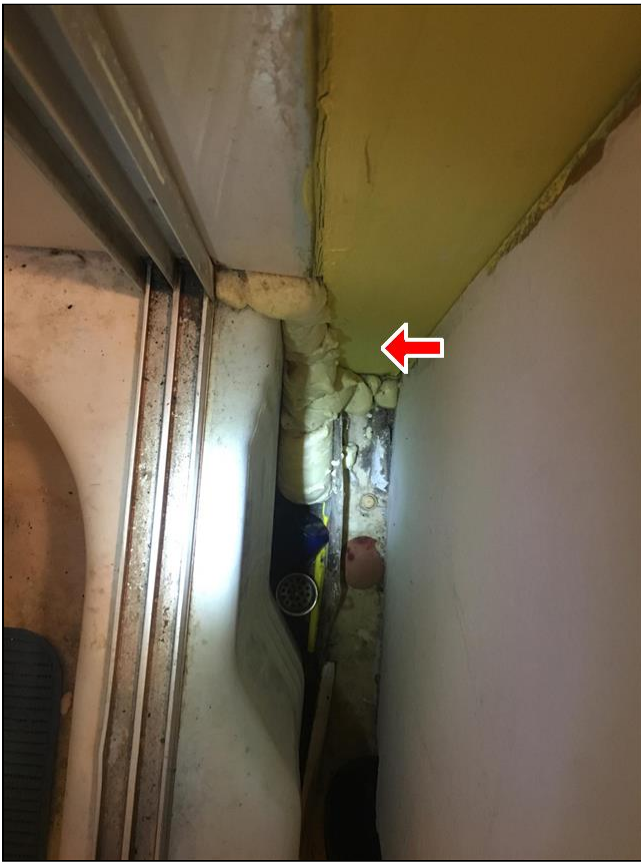
6.1 Item 1(Picture)

6.1 Wall between tub cabinet caulked; this may deteriorate over time; recommend monitoring and repair as needed
