## Inspection Report

Property Address:

**Allegiance Inspections LLC**

<b>Date:</b> 4/11/2019	<b>Time:</b> 09:45 AM	<b>Report ID:</b> 041119-edisto
<b>Property:</b> [REDACTED]	<b>Customer:</b> [REDACTED]	<b>Real Estate Professional:</b> [REDACTED]

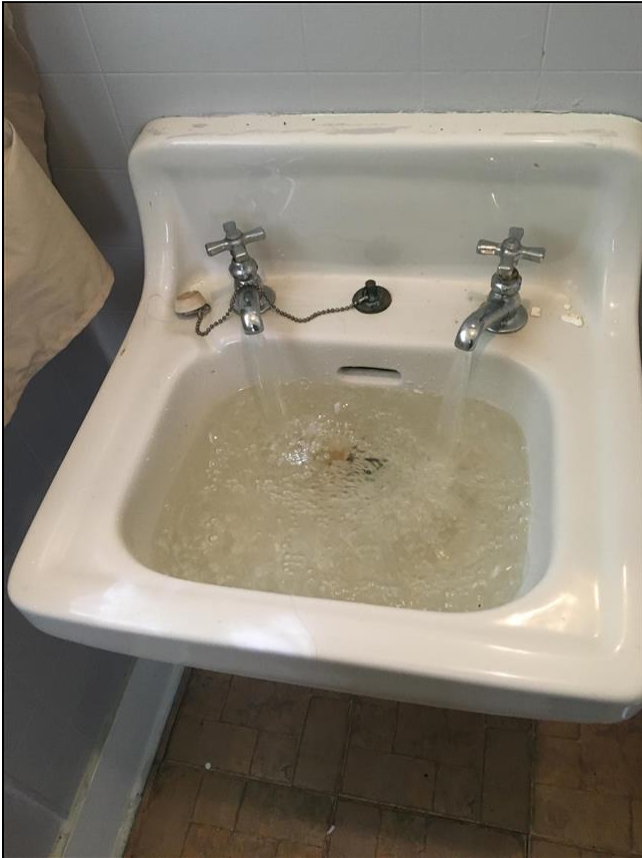
6.6 Item 1(Picture)

**6.6** Sink in master half bath draining slow; recommend repair using a budget friendly method first i.e. drain "snake" or chemical drain cleaner. If this does not work, recommend evaluation by a professional plumber.

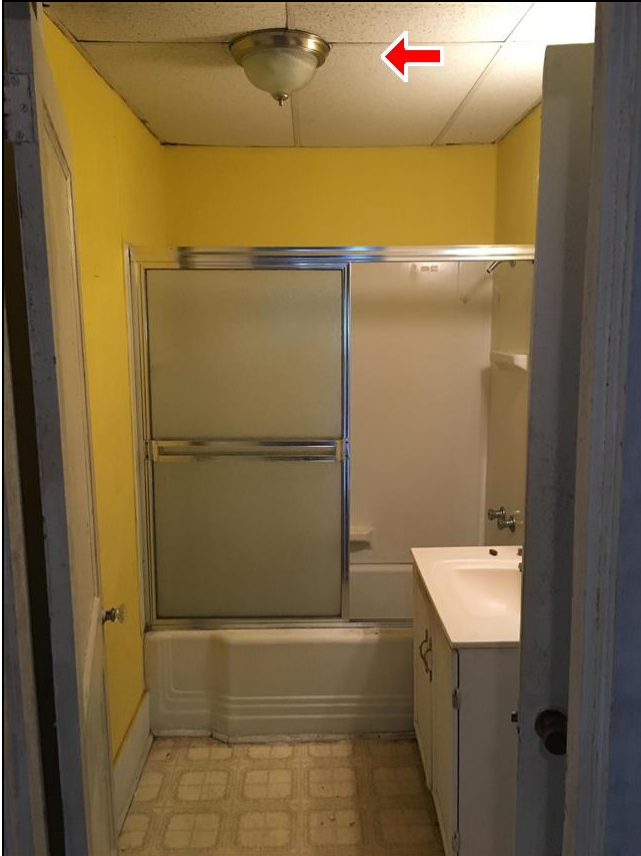
6.8 Item 1(Picture)

**6.8 (1)** One electric receptacle in hall bath embedded in light fixture; this type of configuration is not grounded and not recommended for use near water sources; this is a safety hazard; recommend licensed electrician install proper GFCI receptacles in both bathrooms.

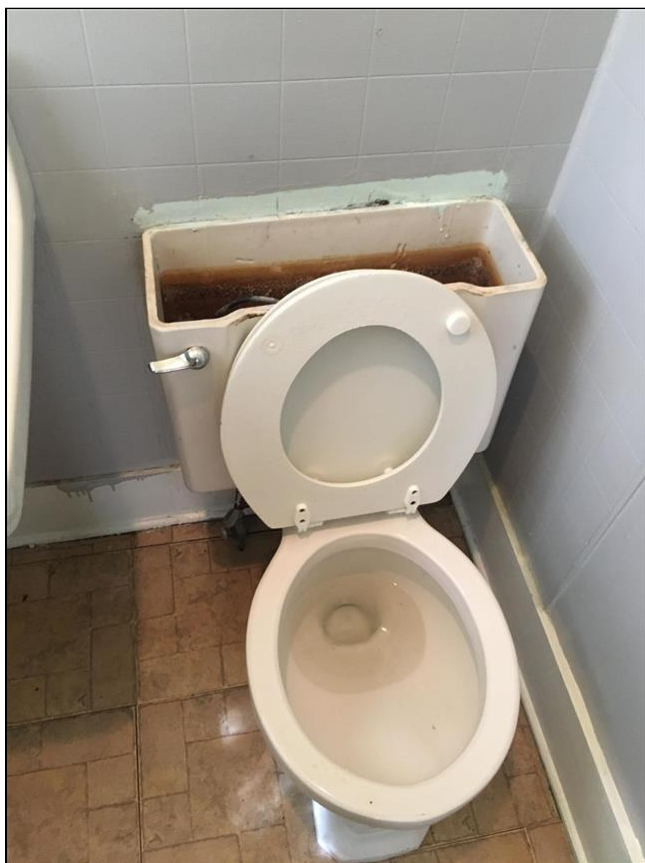
6.8 Item 2(Picture)

**6.8 (3)** Toilet in master half bath did not work at time of inspection; recommend repair or replace

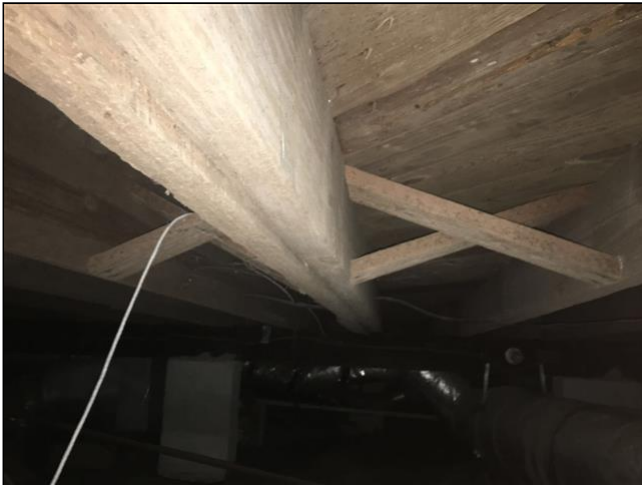
Joists in crawlspace

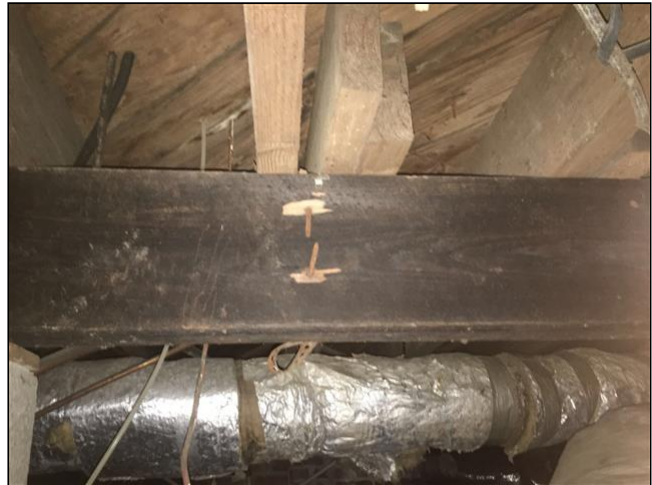
Girder in crawlspace

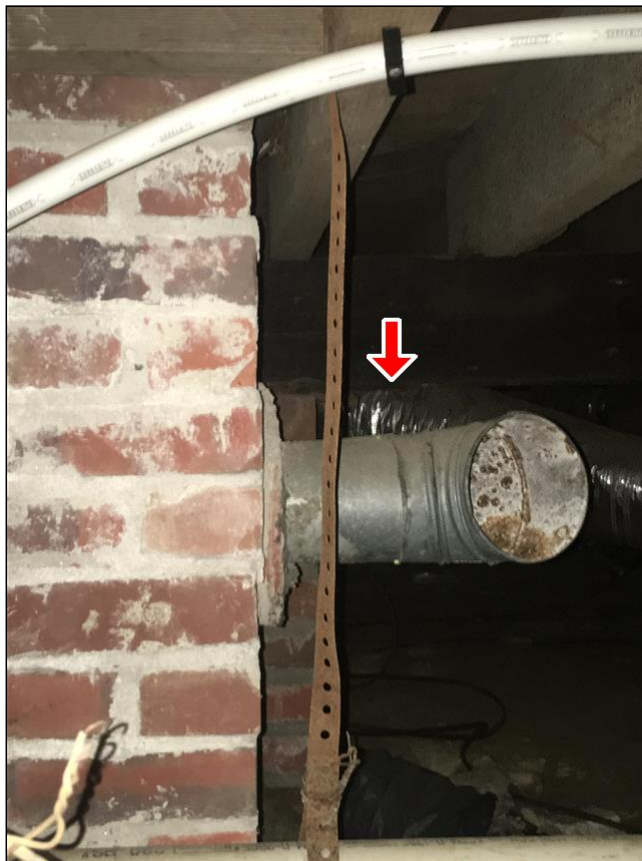
Apparent chimney clean out in crawlspace- see illustration

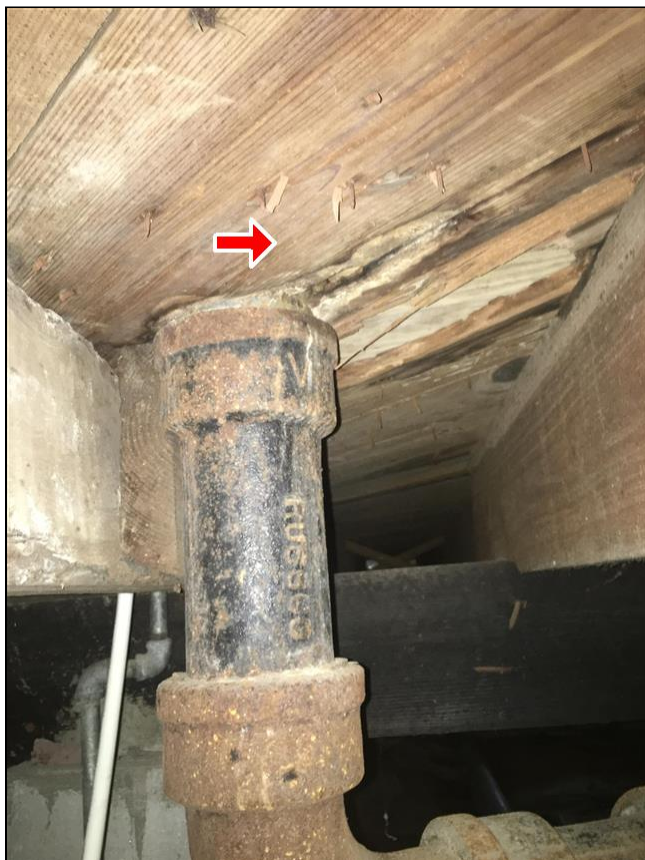
7.3 Item 1(Picture)

7.3 Damaged subfloor near pipe entry; recommend repair by qualified contractor

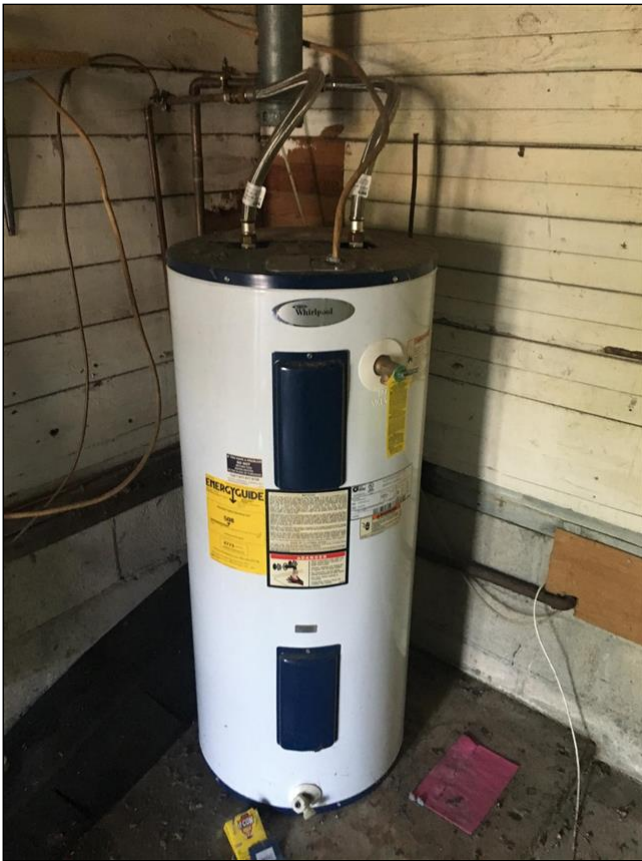
Water heater age: 2010 approx 9 years

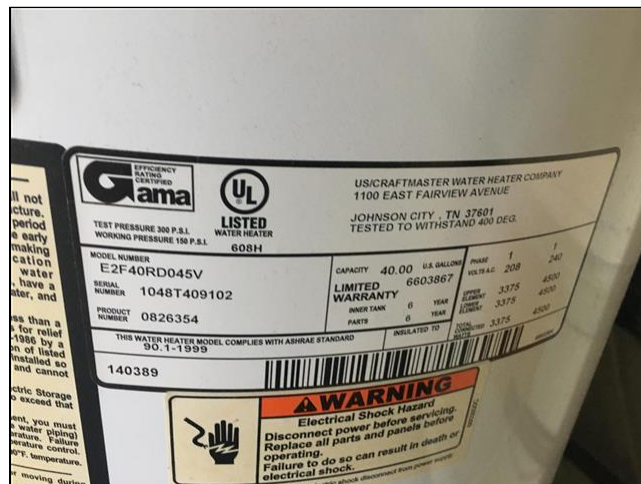
Water heater data label

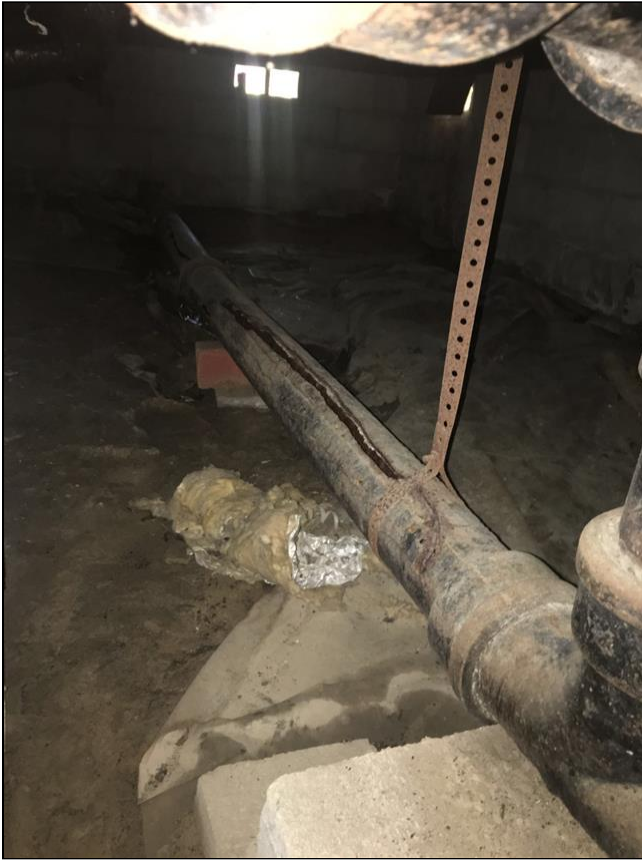
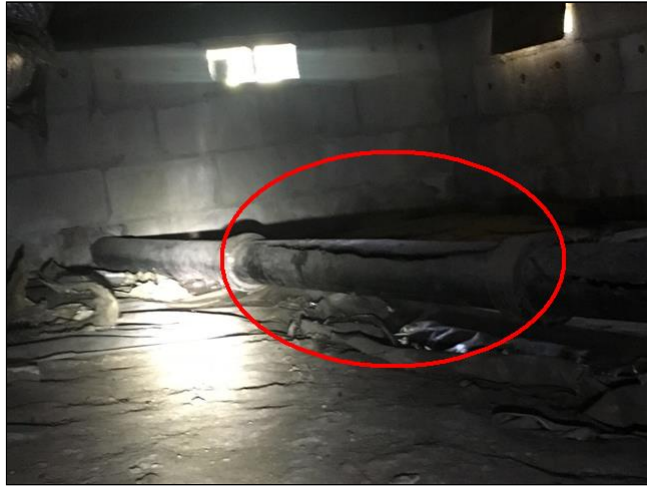
**8.0** (1) Video of water leak and damaged cast iron pipes in crawlspace; recommend replacing all damaged pipes by qualified professional plumber

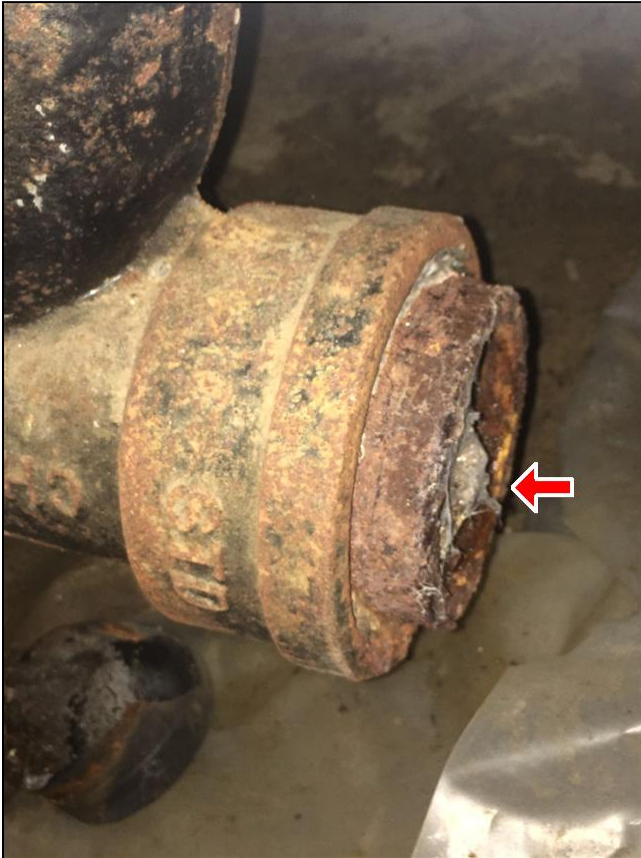
8.0 Item 5(Picture)

**8.0** (2) Rust present on cast iron pipes; debris present on inside; recommend upgrading plumbing waste system in crawlspace as necessary

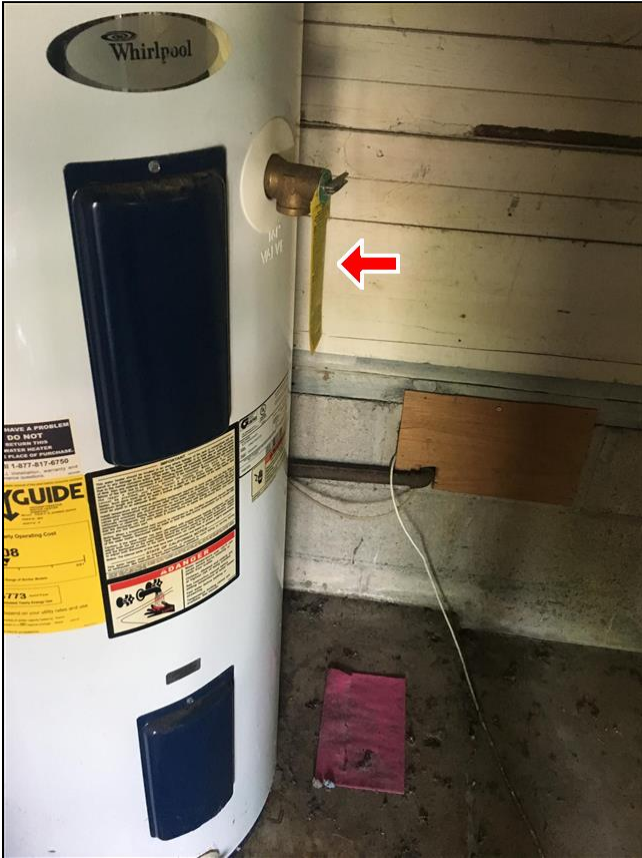
8.2 Item 1(Picture)

**8.2** The T&P (Test and Pressure) valve on water heater needs a 3/4 threaded pipe to extend within 6 inches of floor for safety. (PVC is not approved for hot water use). I recommend repair by a qualified person.

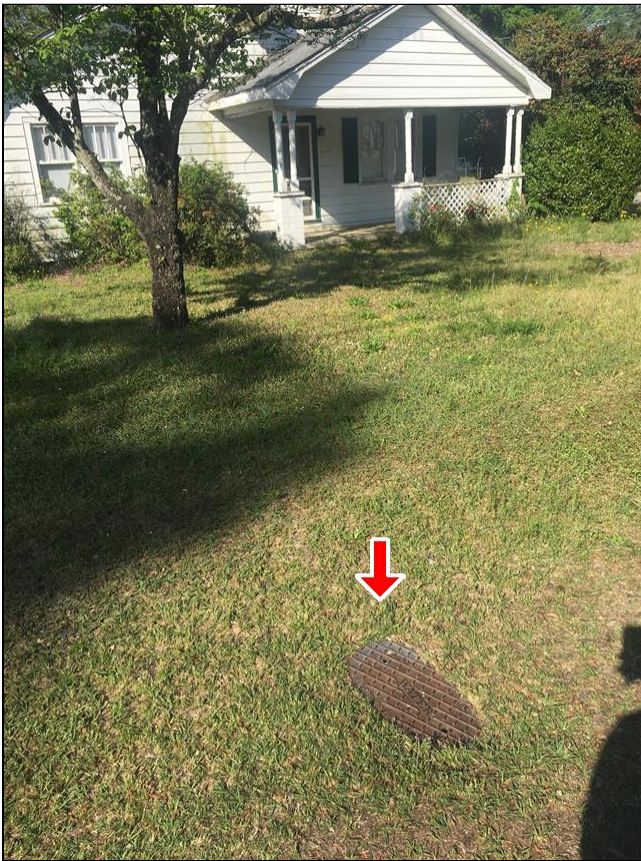
8.3 Item 1(Picture)

**8.3 Main water shut off**

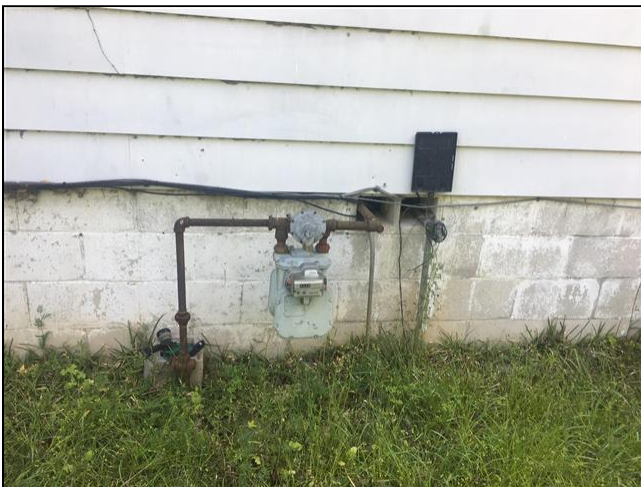
8.5 Item 1(Picture)

**8.5 Main gas shut off**

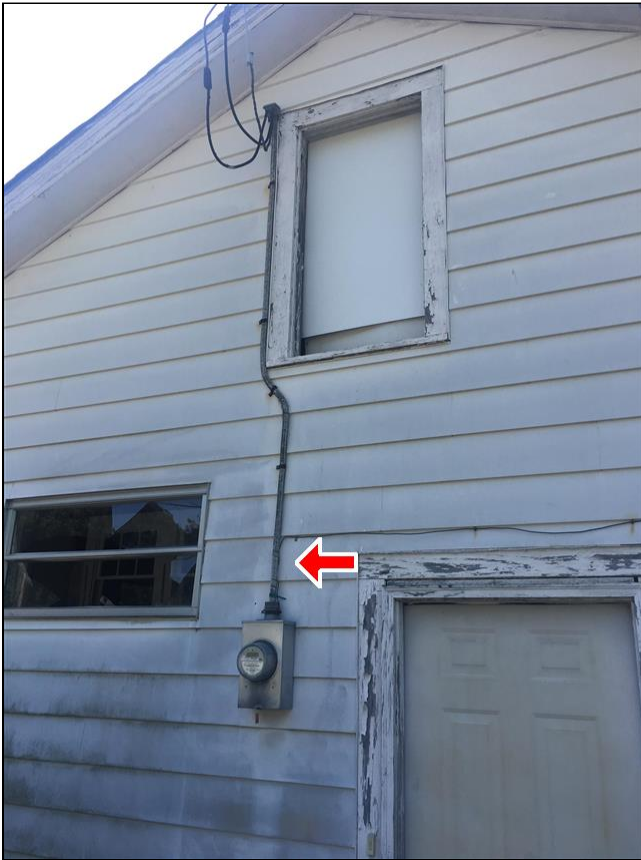
9.0 Item 1(Picture)

9.0 The electrical service conductors are frayed at wire sheathing outside and needs repair or replace.

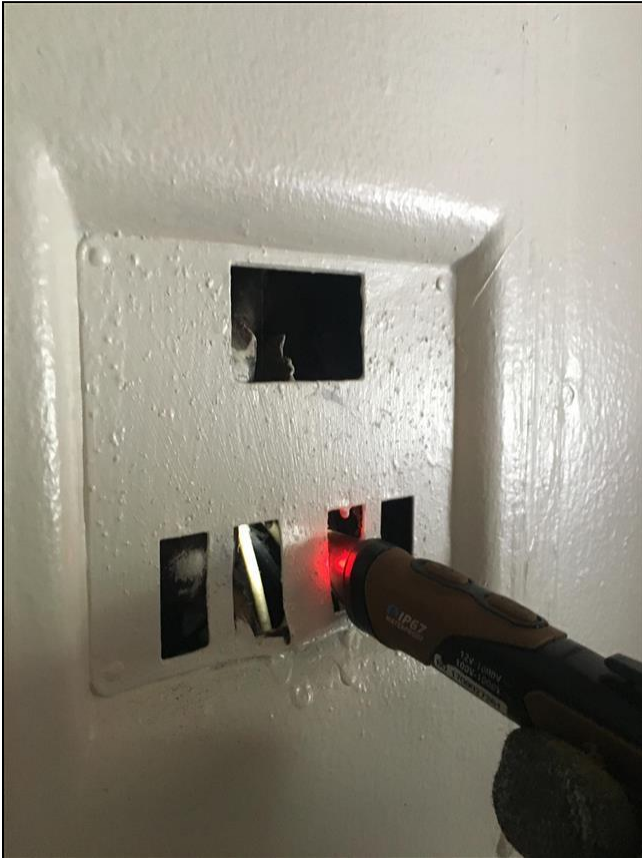
9.1 Item 1(Picture)

9.1 (1) Electric subpanel in kitchen missing areas of protective covering; tester shows active "hot" wires easily accessible; recommend repair by licensed electrician - safety hazard

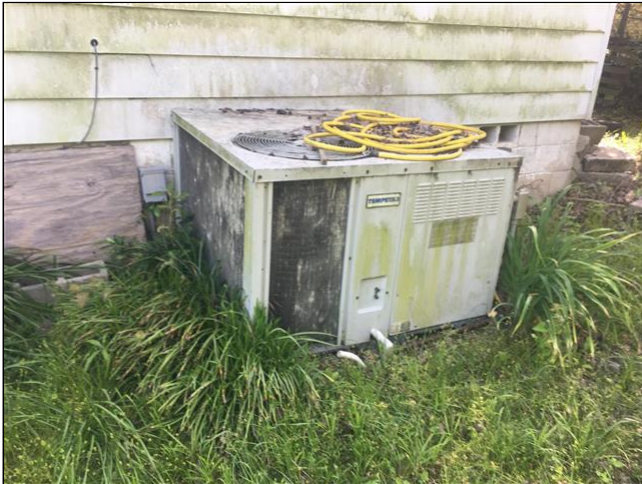
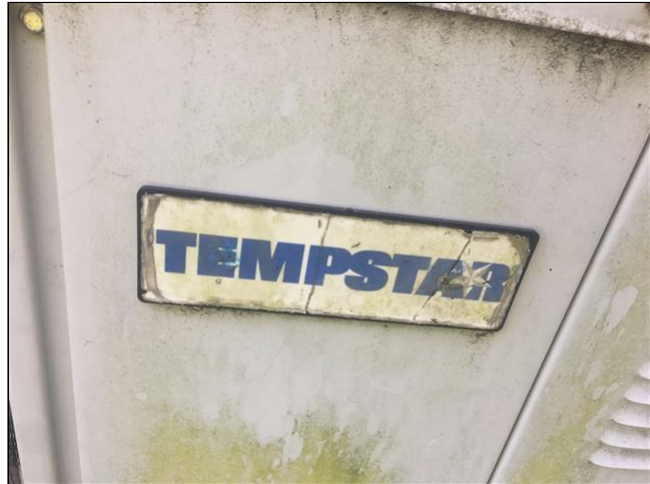
HVAC Age: 1995 approx 24 years

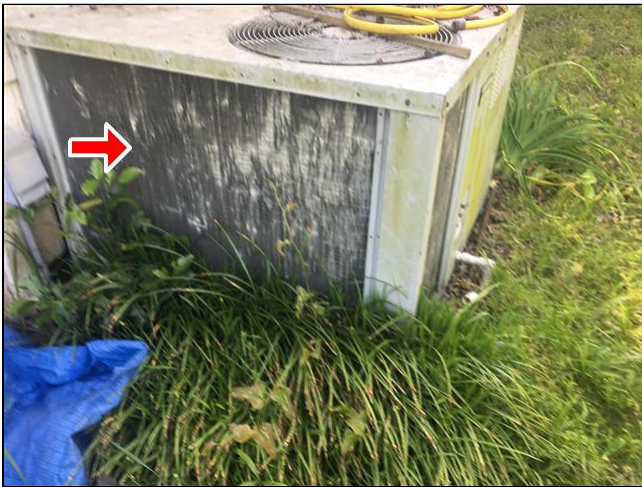
10.0 Item 1(Picture)

10.0 HVAC fins damaged; recommend HVAC specialist evaluate and replace if necessary

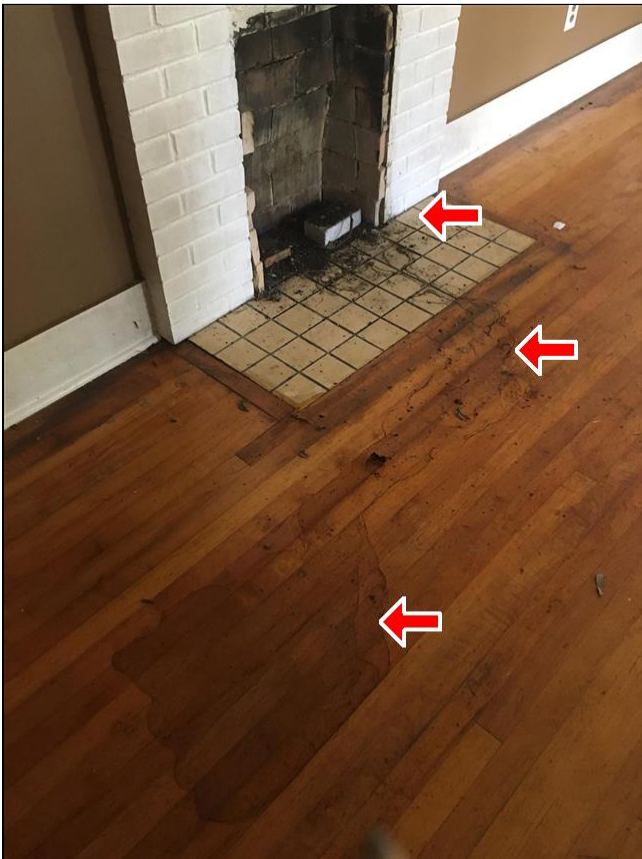
10.6 Item 1(Picture)

10.6 Apparent moisture stain starting from fire box moving onto flooring; recommend qualified contactor evaluate and repair any leaks as necessary

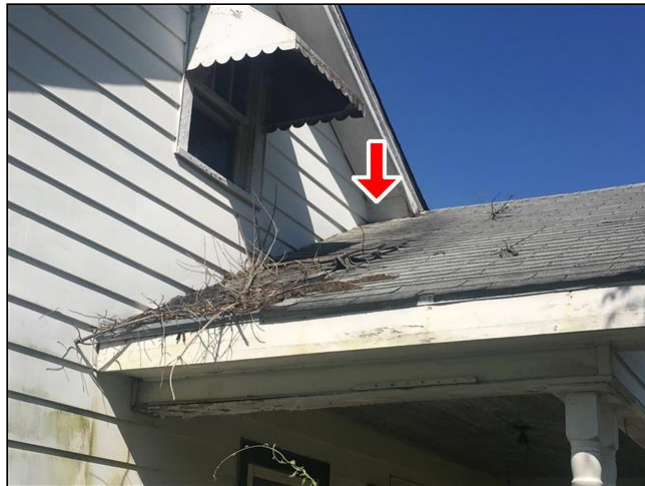
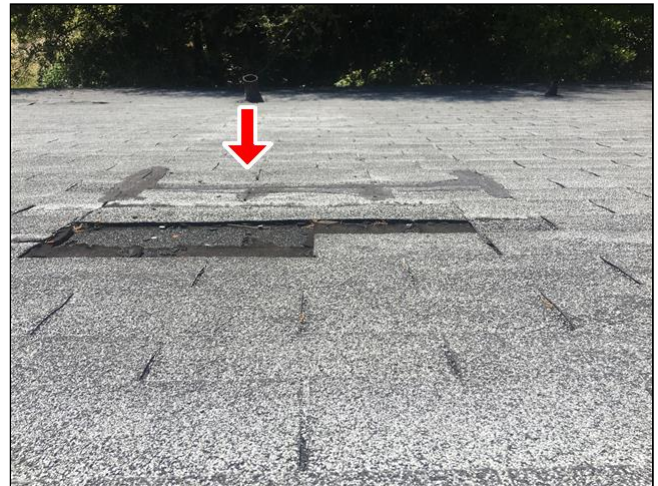
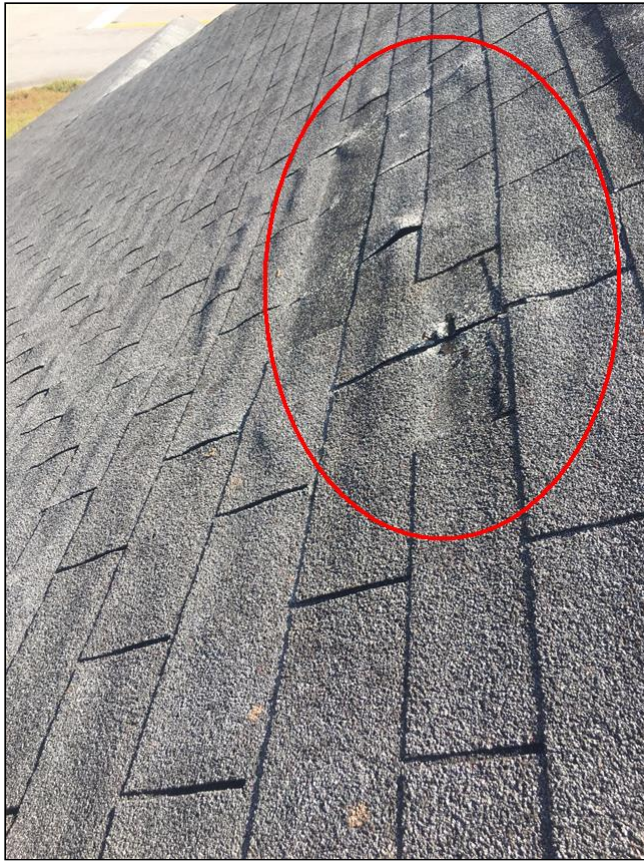
(2) Shingles have holes, missing, damaged, blistering , loose. It appears roof has **reached the end of its useful life: recommend roof replaced by a qualified professional roofing contractor**

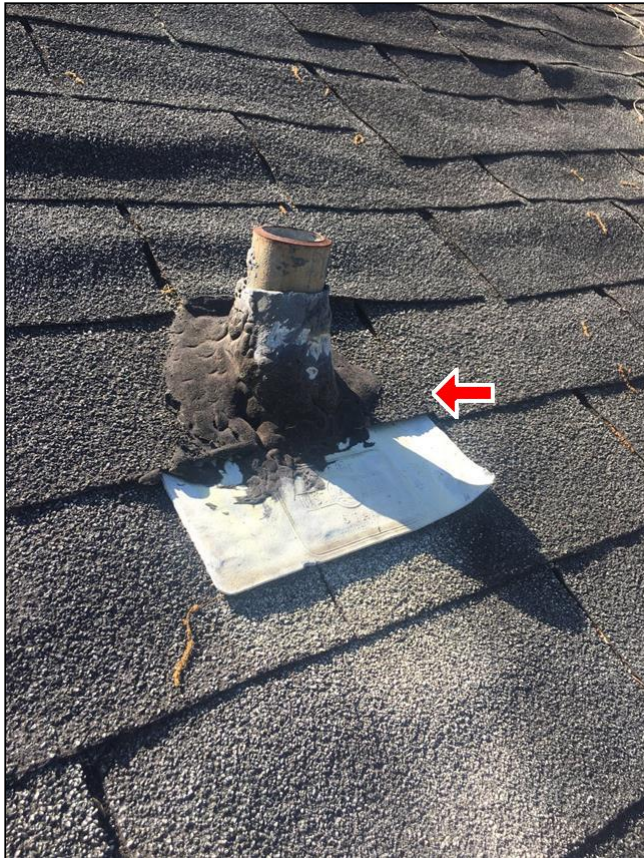
1.1 Item 1(Picture)

(1) Improper flashing at plumbing vent; recommend replacing by qualified professional roofer

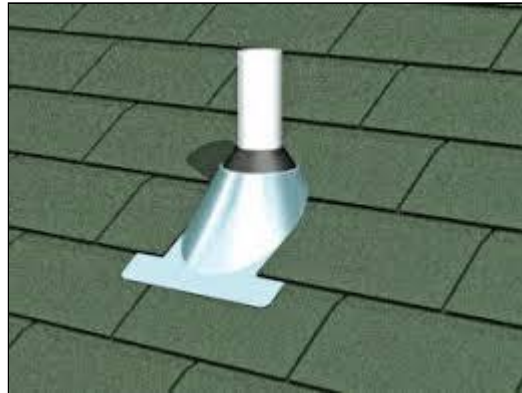
1.1 Item 2(Picture) Illustration of proper plumbing vent installation

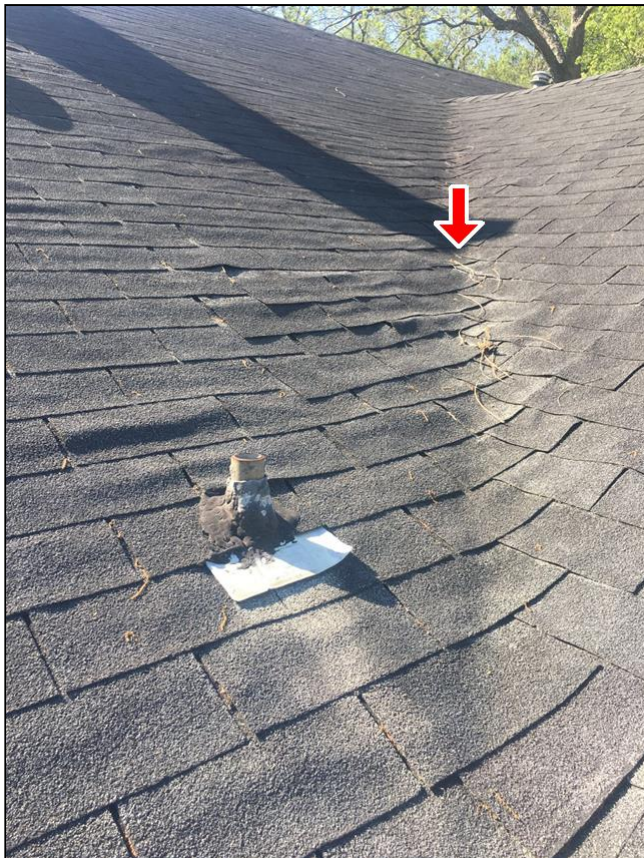
1.1 Item 3(Picture)

(2) Asphalt shingle flashing in valley blistering/damaged recommend replacing

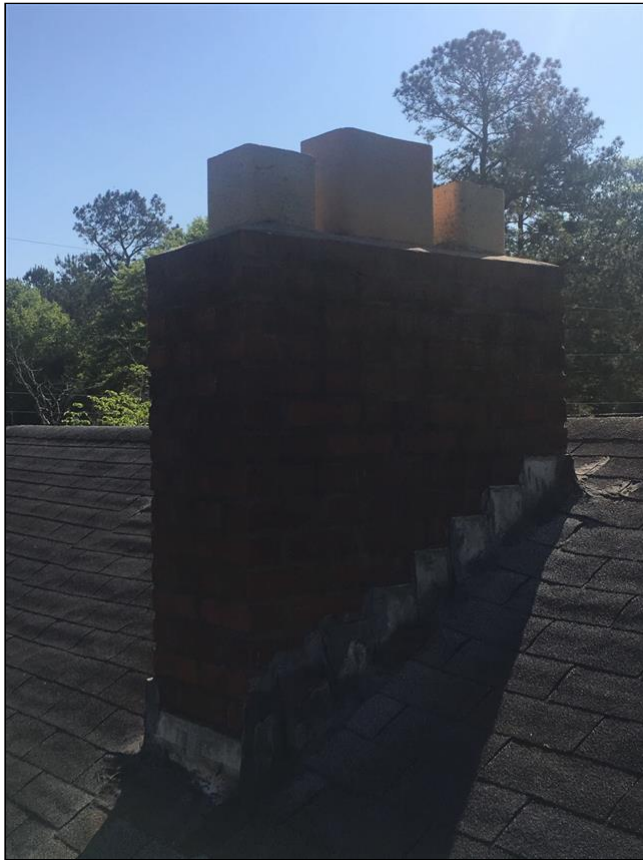
1.2 Item 1(Picture) Exterior chimney chase

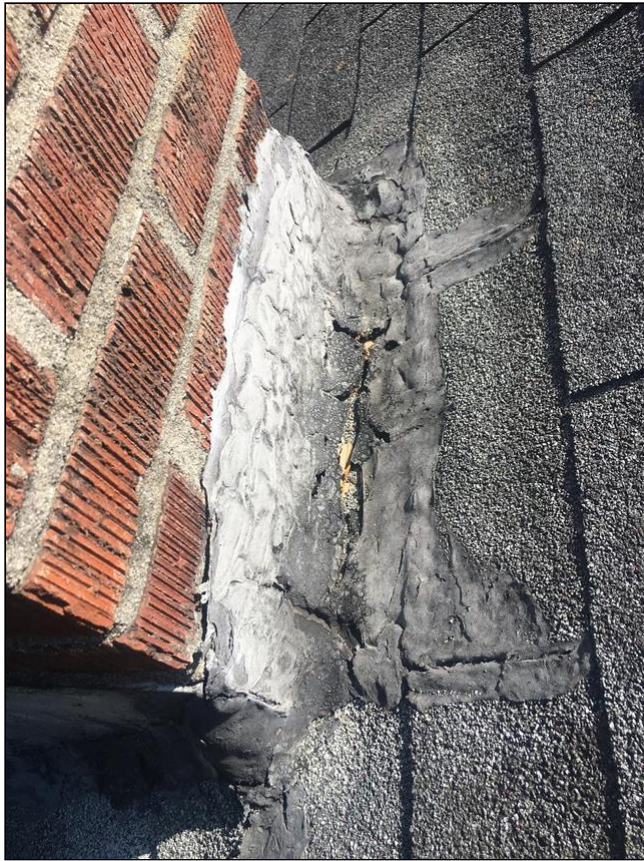
1.2 Item 3(Picture)

Step flashing on exterior chimney chase sealed with apparent roof tar; recommend monitoring and repair when necessary

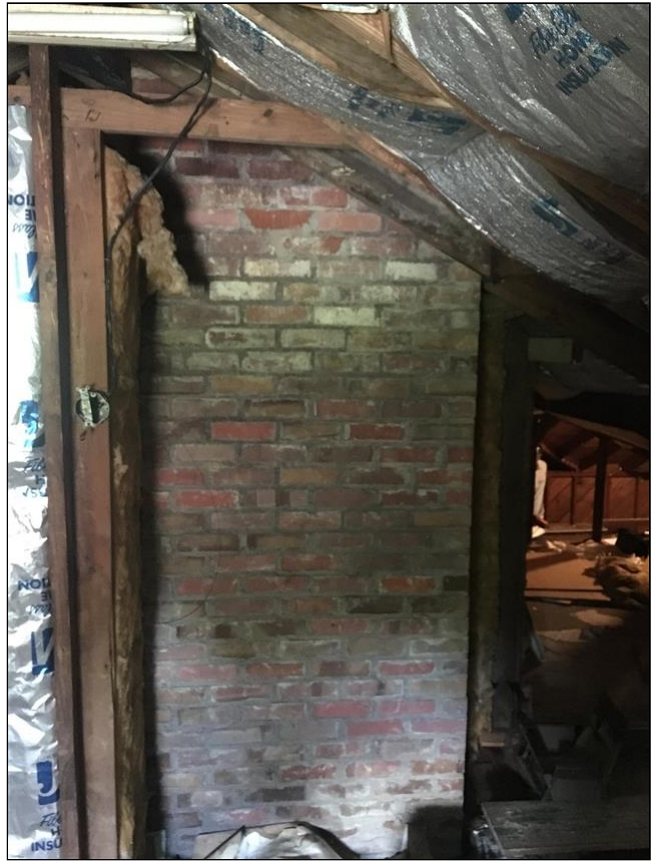
1.2 Item 4(Picture) Chimney chase in attic

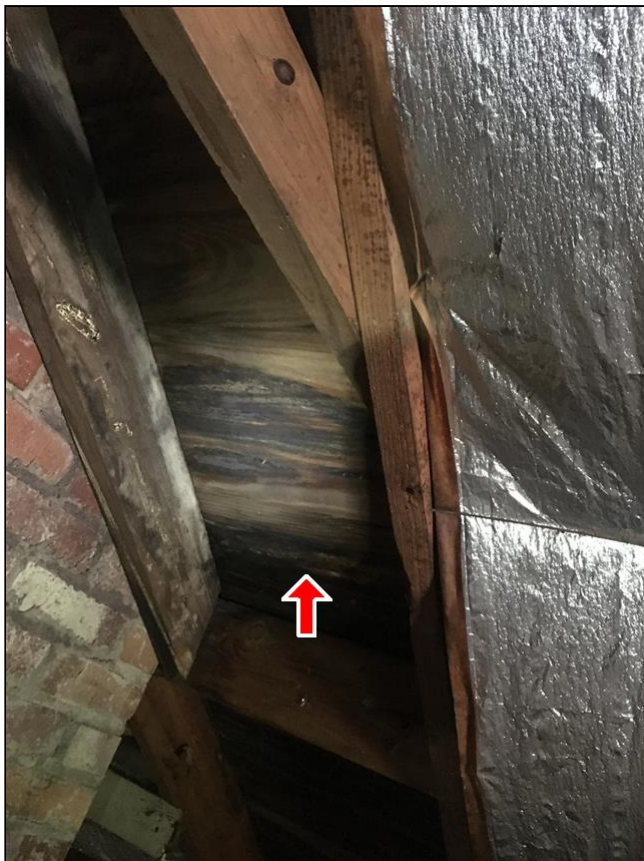
Apparent moisture stains on sheathing near interior chimney chase in attic

1.2 Item 5(Picture) Moisture stain near chimney chase in attic

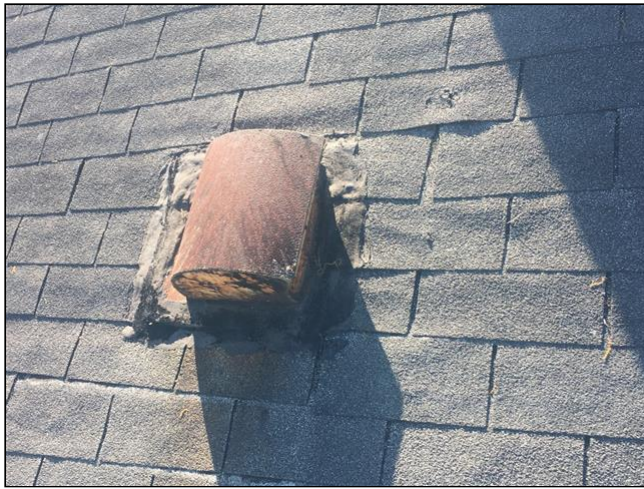
1.2 Item 6(Picture)

(2) Roof vent rusted; recommend replacement by qualified professional contractor

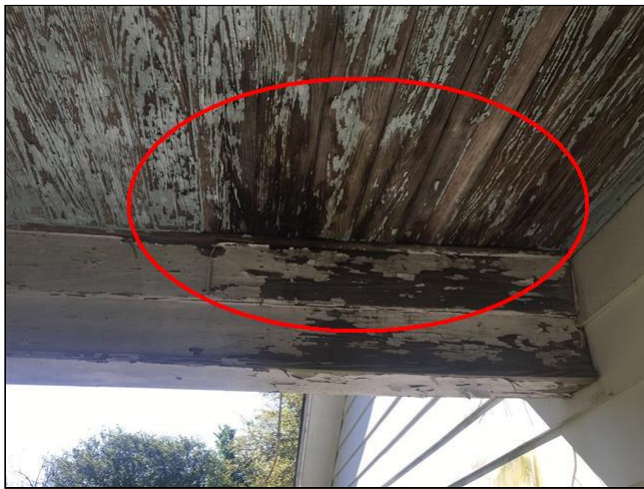
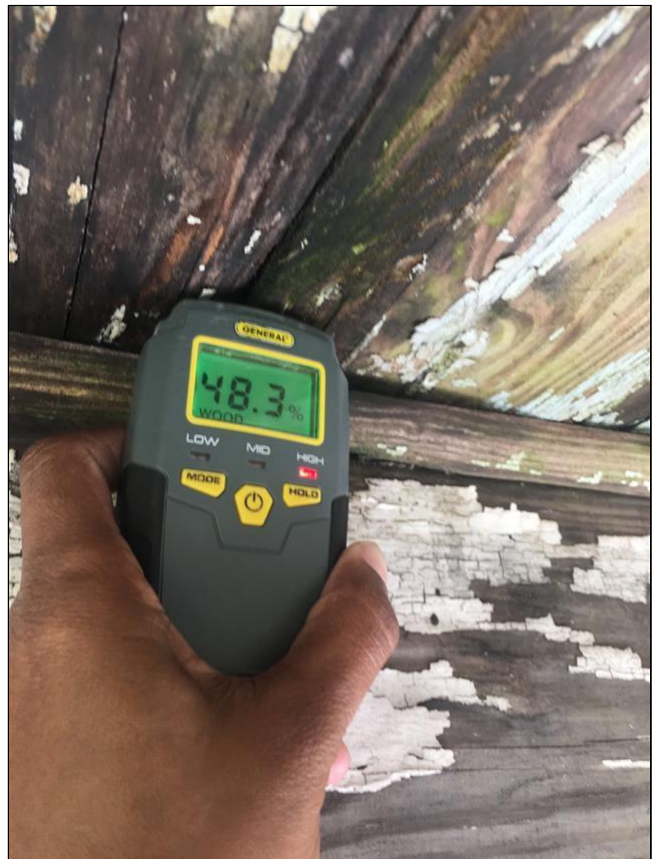
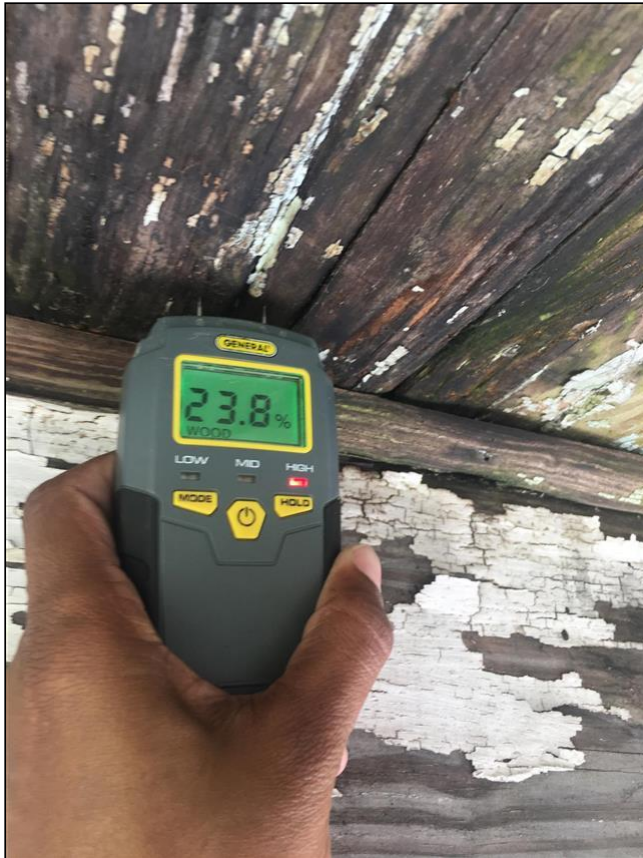
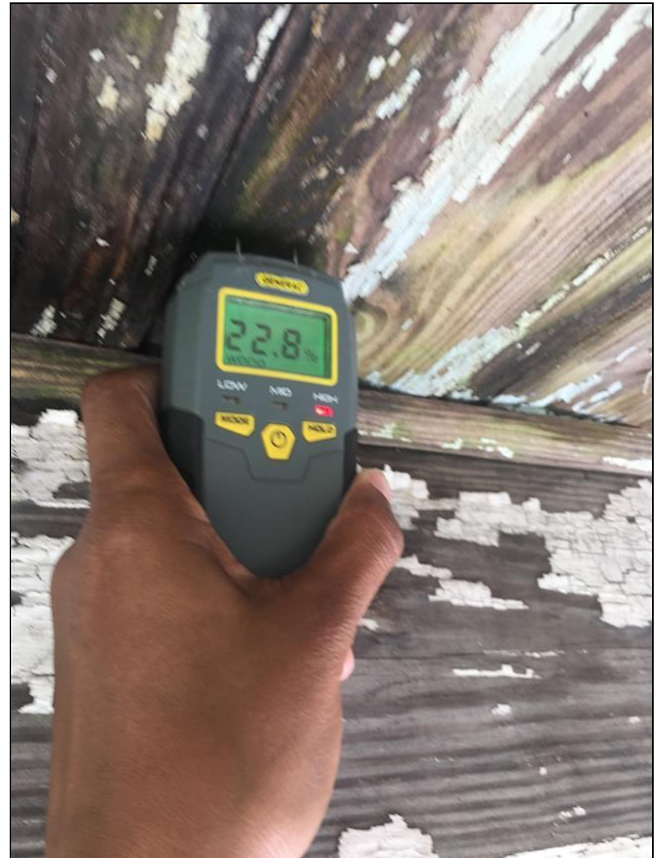
(1) Soft wood/wood rot on exterior ceiling of front entry area; moisture meter readings: 22.8%, 23.8%, 48.3%; the maximum acceptable moisture percentage for wood is 20%. Recommend replacing damaged areas as applicable

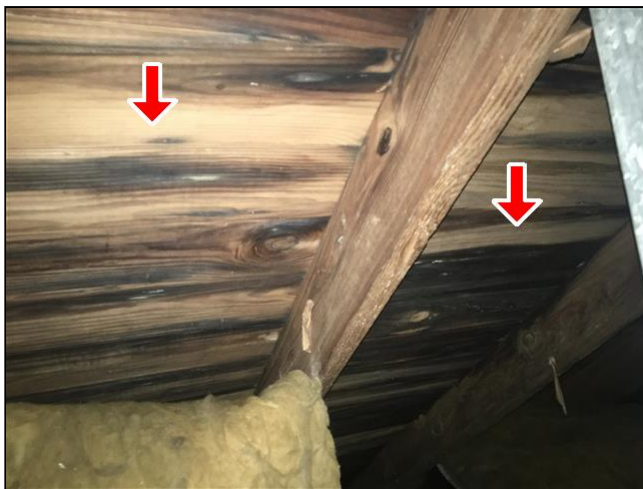
1.5 Item 5(Picture)

(2) Moisture stains on sheathing in attic; recommend evaluation by qualified professional roofer and repair or replace as necessary

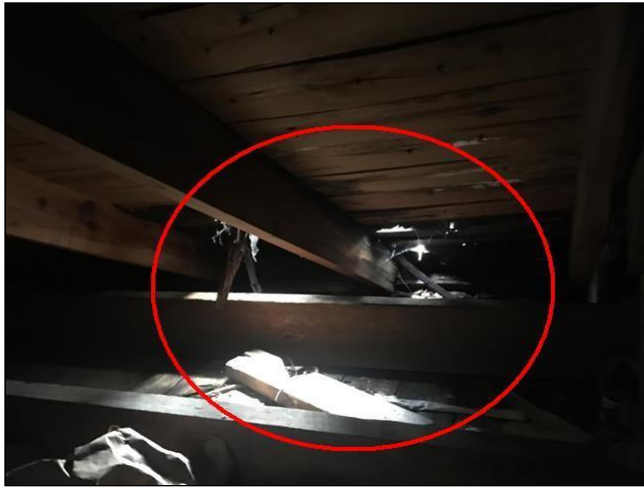
1.5 Item 6(Picture)

(3) Hole in roof deck; recommend repair by qualified professional roofer

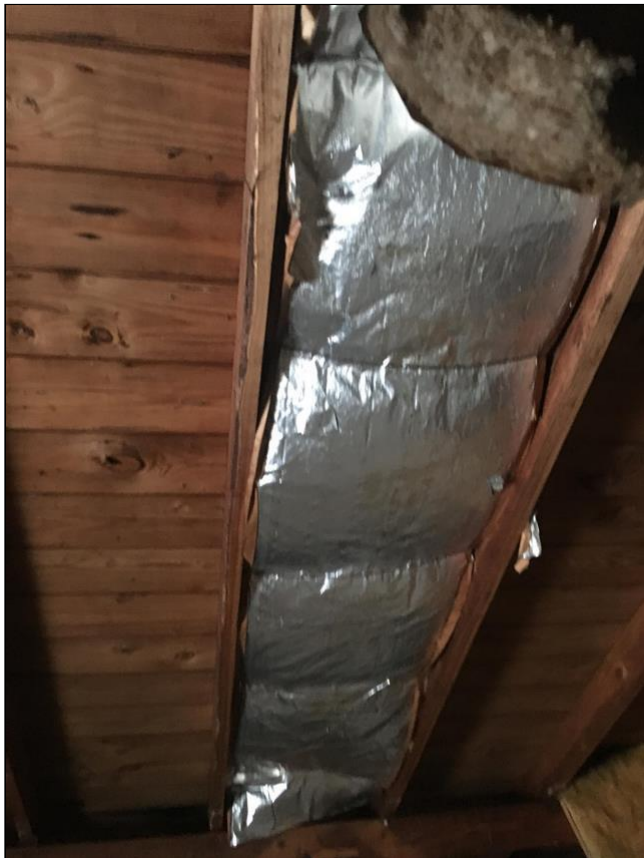
1.7 Item 1(Picture)

Insulation failing throughout attic area; apparent install on underside of roof deck; recommend repair by qualified contractor

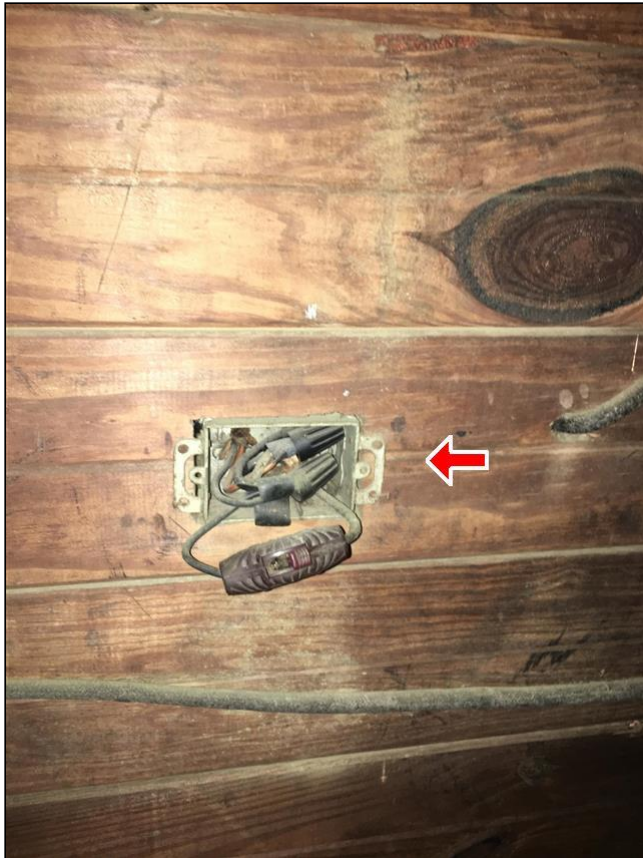
1.8 Item 1(Picture)

Open junction boxes in attic; recommend repair or replace all open junction boxes, loose wires as applicable

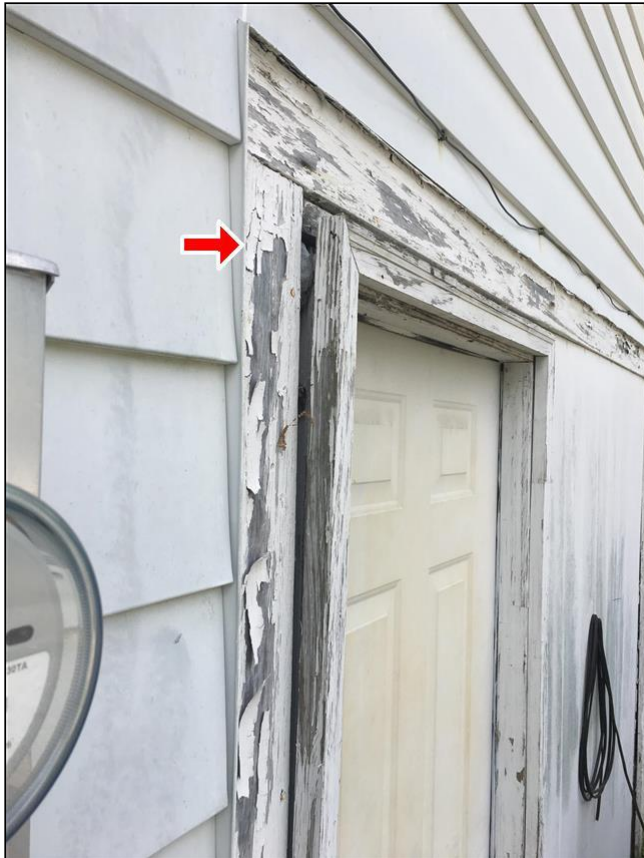
2.1 Item 1(Picture)

Door frame detached from casing; recommend repair

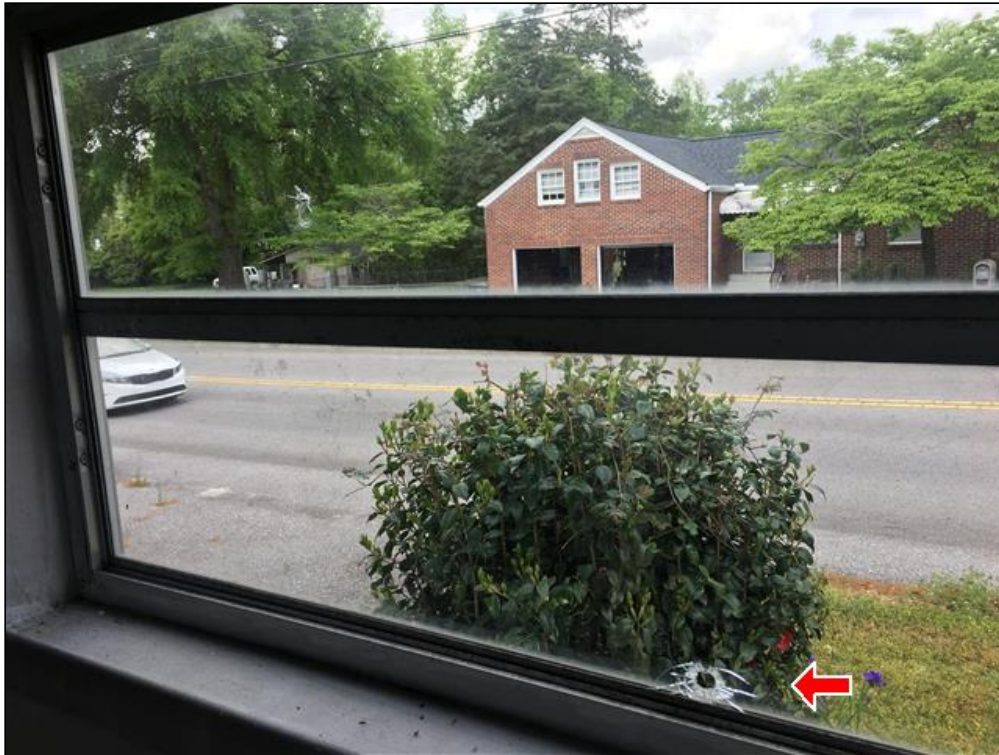
2.2 Item 2(Picture)

2.2 Item 1(Picture) Exterior view of damaged windows

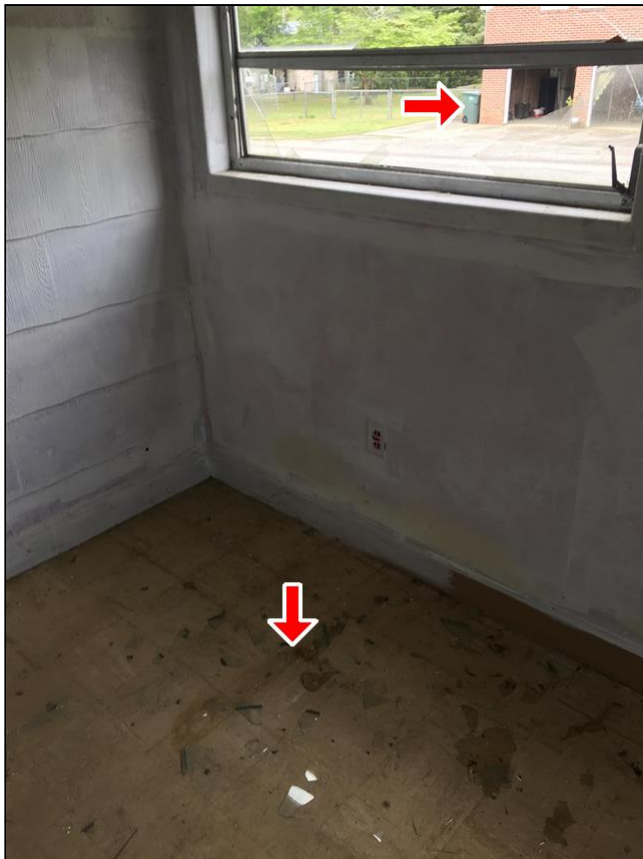
2.2 Item 3(Picture) Glass broken/shattered - on floor  
(2) Multiple windows missing; recommend installing

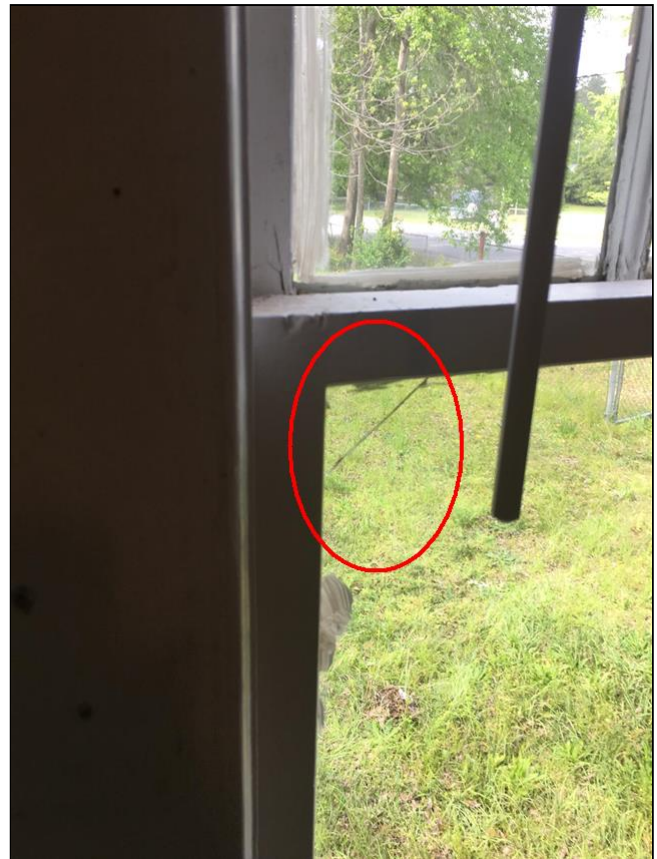
2.2 Item 4(Picture) Cracked window glaze

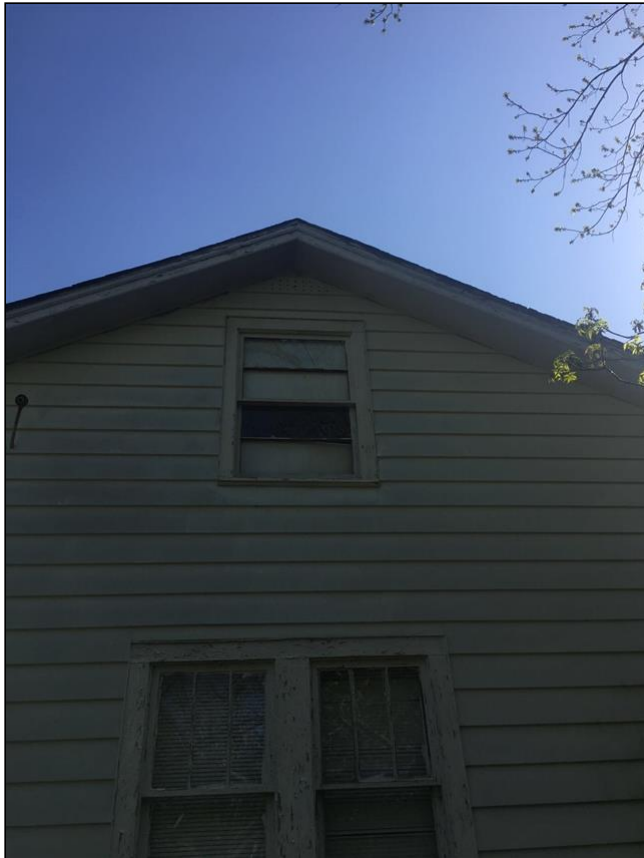
2.2 Item 5(Picture) Exterior view of missing window

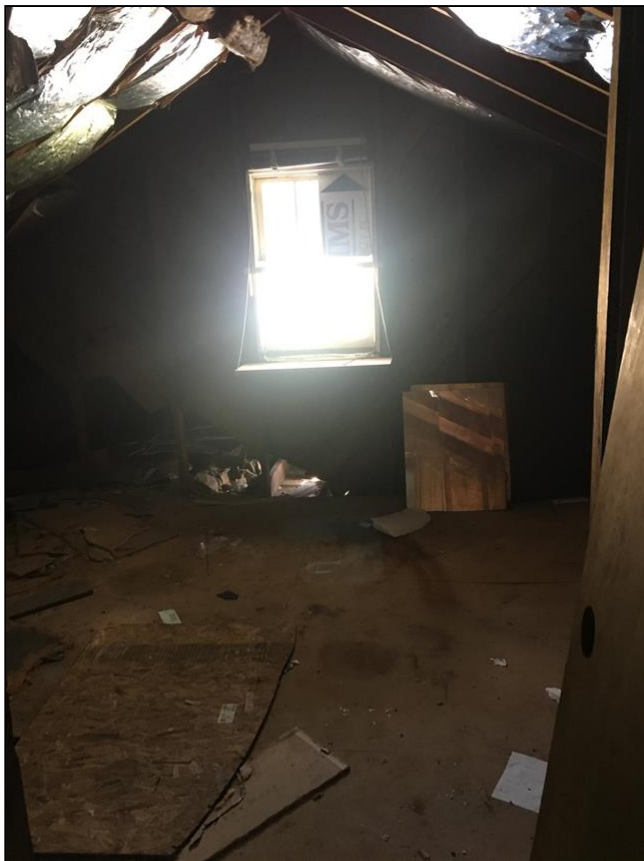
2.2 Item 7(Picture) Damaged window in attic
