## Inspection Report

Property Address:

**Allegiance Inspections LLC**

<b>Date:</b> 4/11/2019	<b>Time:</b> 09:45 AM	<b>Report ID:</b> 041119-edisto
<b>Property:</b> [REDACTED]	<b>Customer:</b> [REDACTED]	<b>Real Estate Professional:</b> [REDACTED]

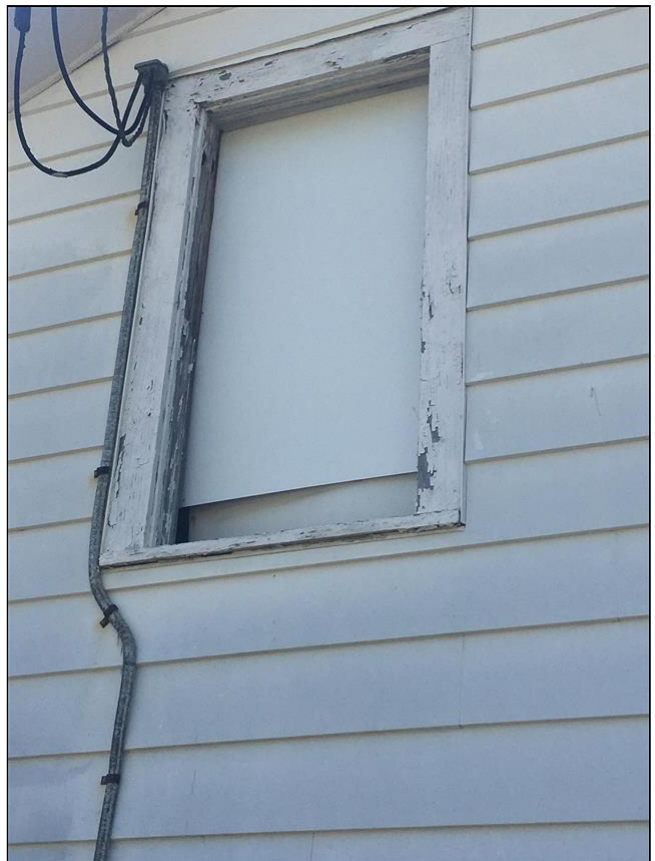
2.2 Item 8(Picture) Window missing

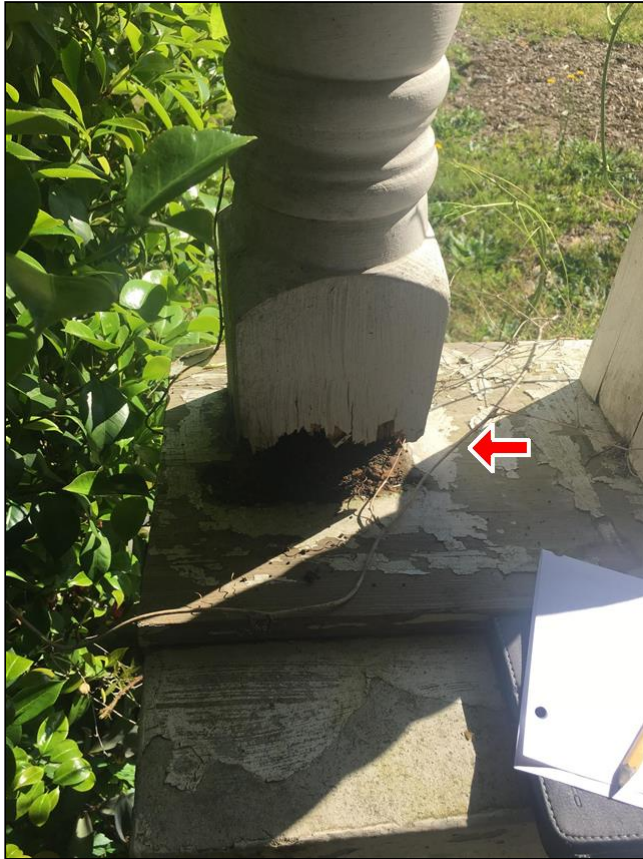
2.3 Item 1(Picture)

Wood support post damaged/wood rot; recommend replacing

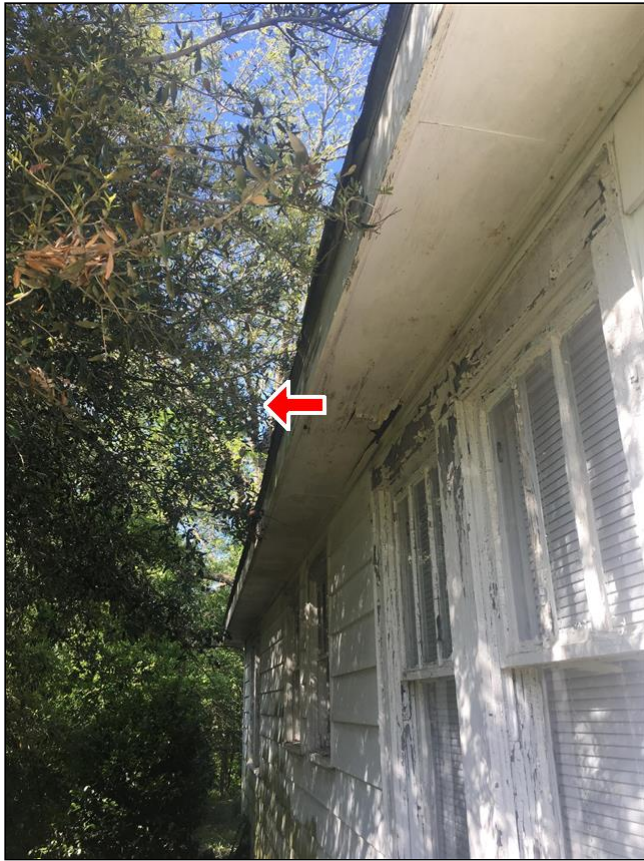
2.4 Item 1(Picture)

The tree limbs that are in contact with roof and siding or hanging near roof and siding should be trimmed to at least 6 inches away from siding; clear from roofline.

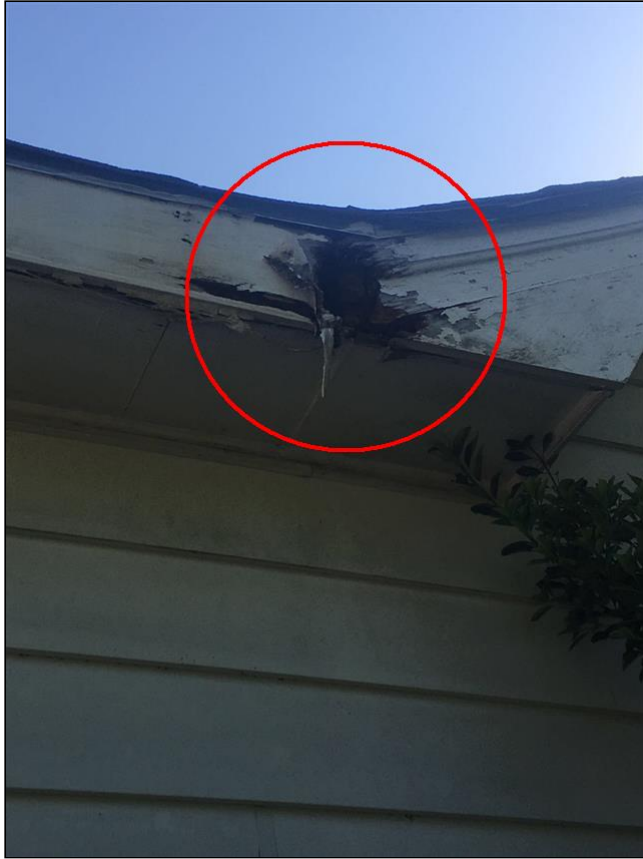
2.5 Item 1(Picture)

Fascia damaged; open areas in the exterior roof system are prone to water and pest intrusion which can cause damage; recommend repair

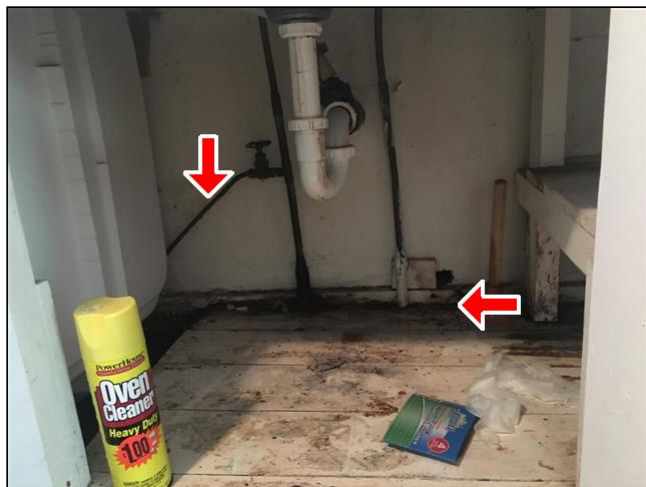
4.6 Item 1(Picture)

Active water leak under kitchen sink; Repairs are needed to stop leaking water from damaging the cabinet bottom or to eliminate moisture that may contribute to fungi growth. A qualified licensed plumber should repair or correct as needed.

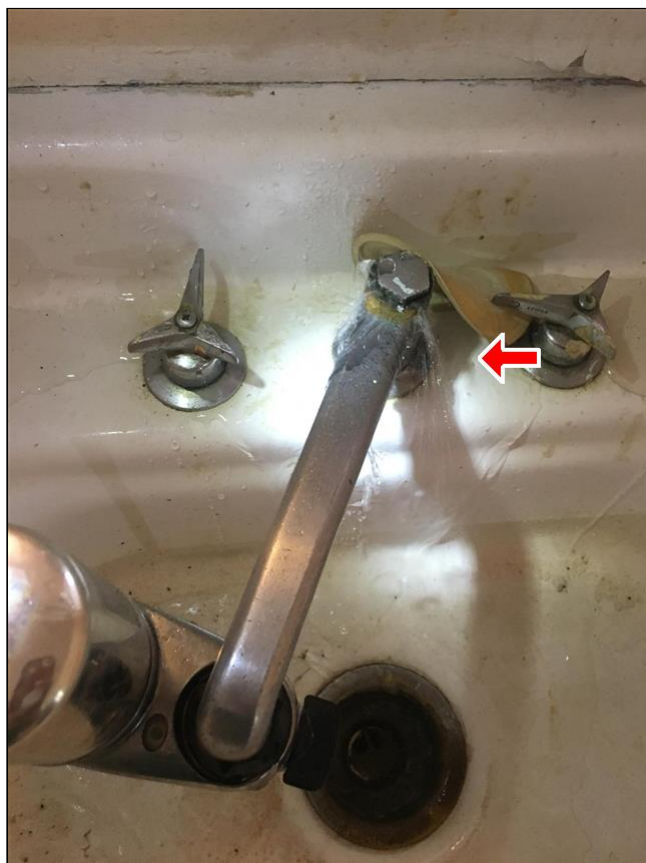
4.7 Item 1(Picture)

The lever on faucet leaks at the kitchen sink. I recommend repair as necessary by a qualified person.

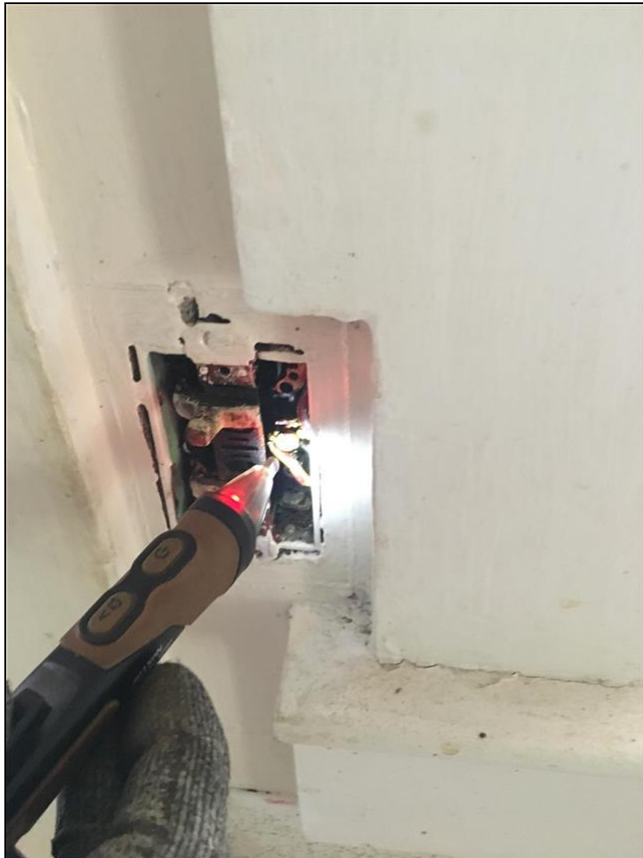
4.8 Item 1(Picture)

Switch missing protective cover with active wires present; this receptacle is located within 6 feet of a water source (kitchen sink); this is a safety hazard; recommend repair by licensed electrician

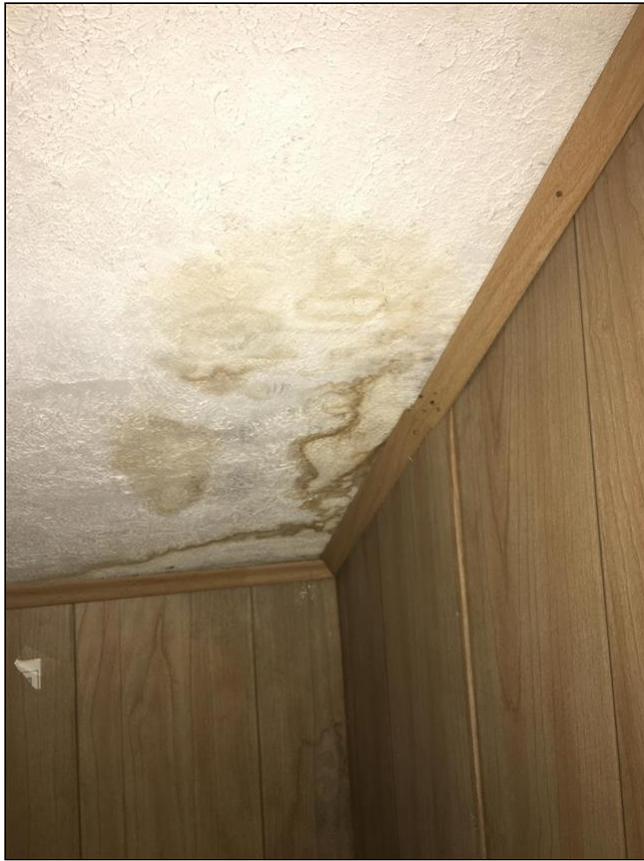
5.0 Item 1(Picture)

Multiple large moisture stains on ceiling at various rooms in the home; recommend repair after replacing roof

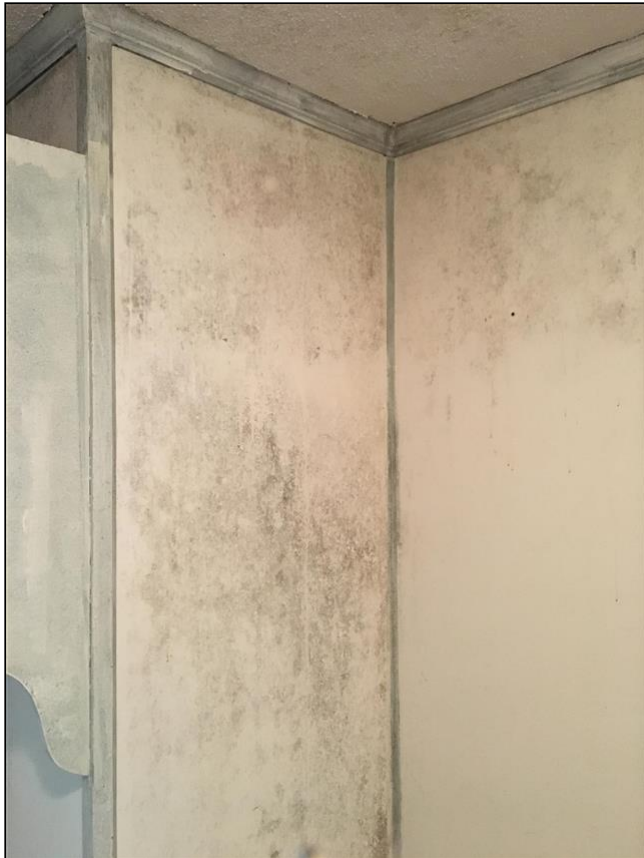
5.1 Item 1(Picture)

Apparent mold present on walls and door frames in hall area; recommend remediation by qualified person

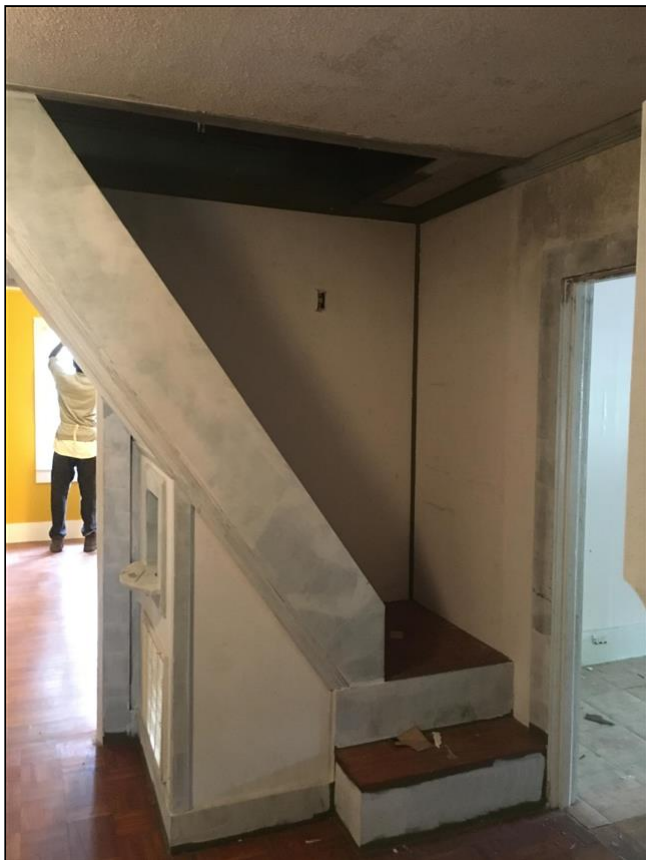
5.3 Item 1(Picture)

(1) The stair structure is improper. Please refer to the illustration photo for proper installation of the stairwell to meet current standards

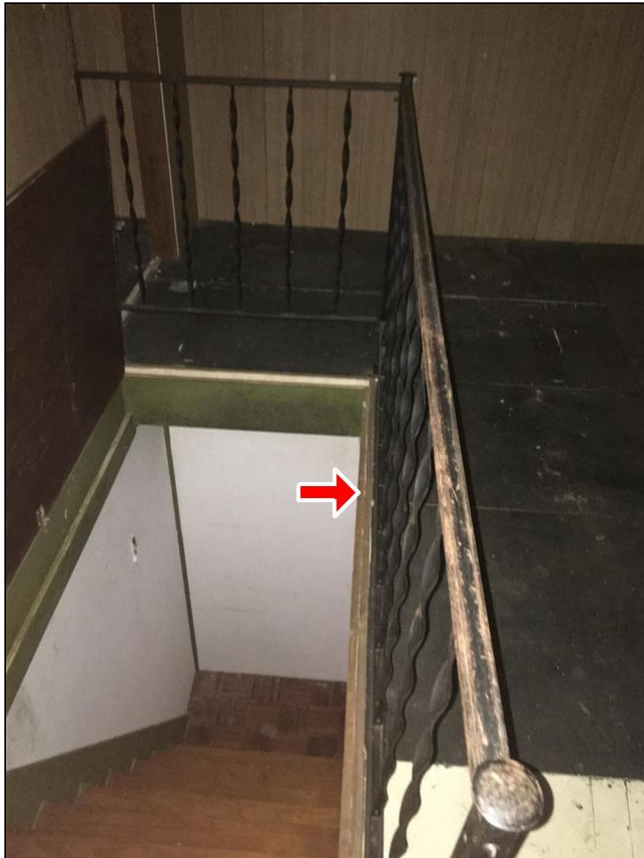
5.3 Item 3(Picture)

(2) The hand/guard rail for the stairs to second level is loose. A fall or injury could occur if not corrected. A qualified contractor should repair or replace as needed.

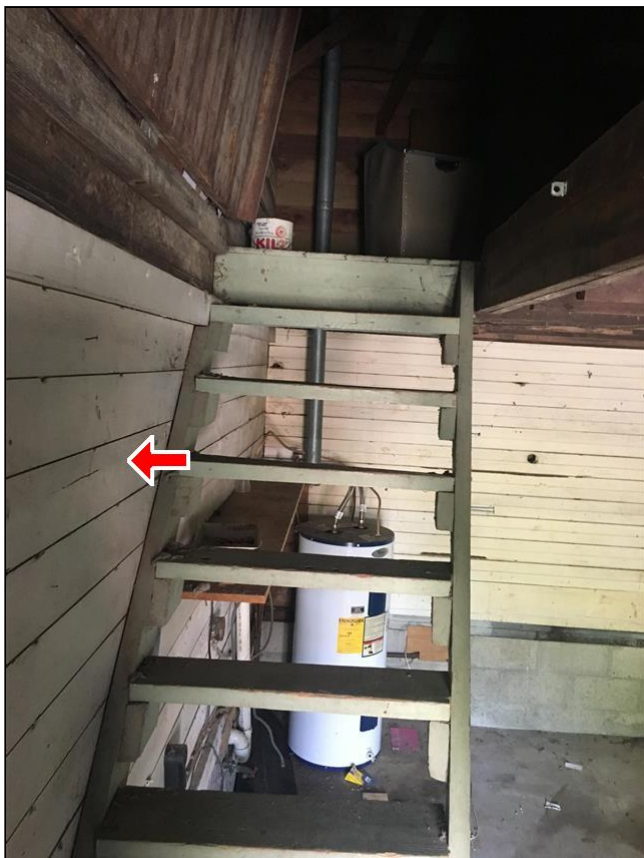
5.3 Item 4(Picture)

(3) Stairs to attic space has no handrail present; recommend installation by qualified person; this is a safety hazard

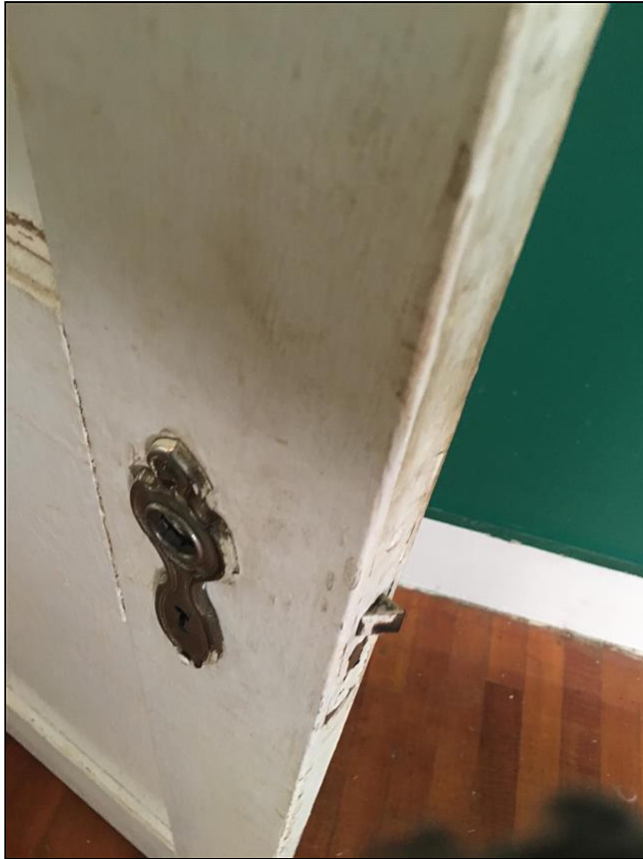
5.4 Item 1(Picture)

(1) Multiple doors missing proper hardware (door knobs); recommend repair

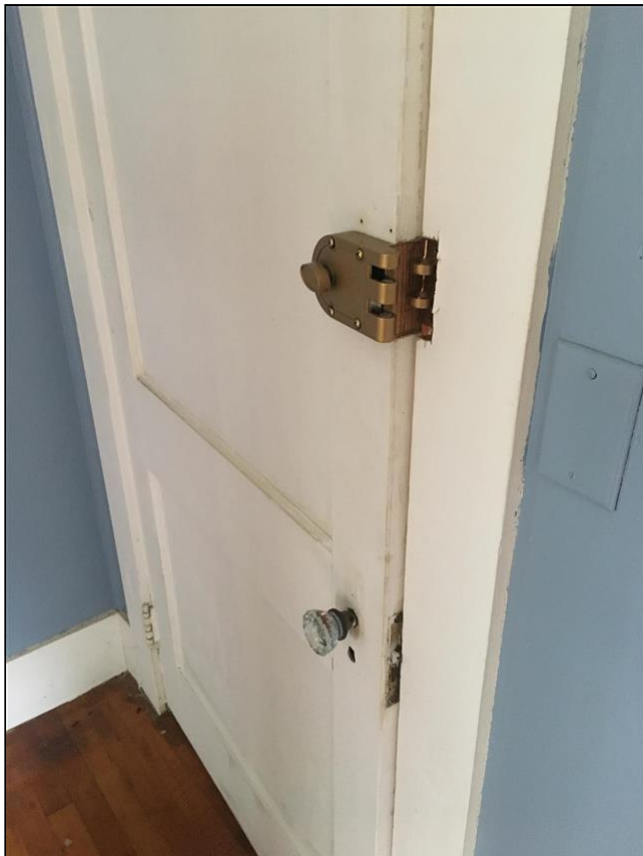
5.4 Item 4(Picture)

(2) Bedroom door would not close properly; not aligned with door frame; recommend repair or replace

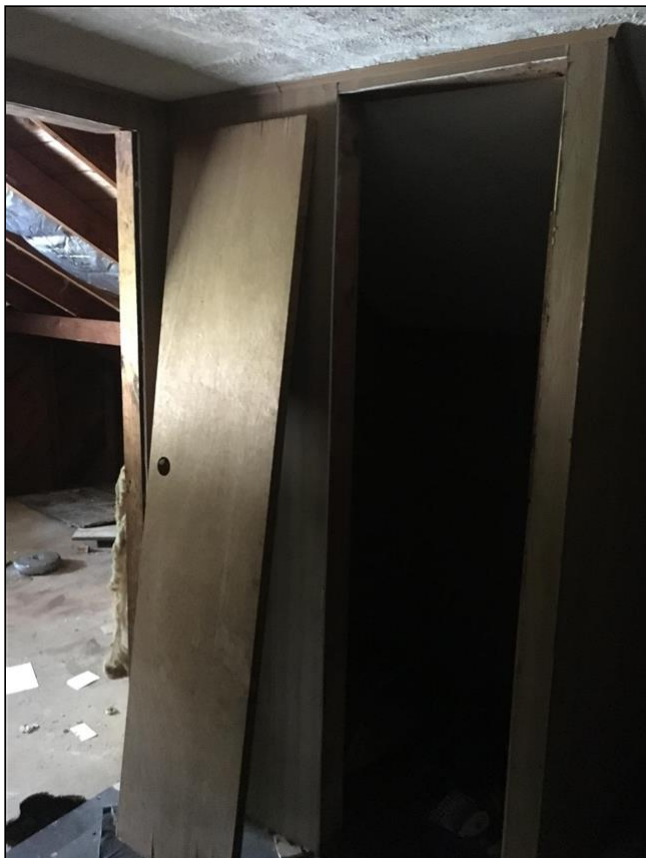
5.4 Item 5(Picture)

(3) No door separating rooms from attic space; this is a safety concern; recommend installation of doors where needed

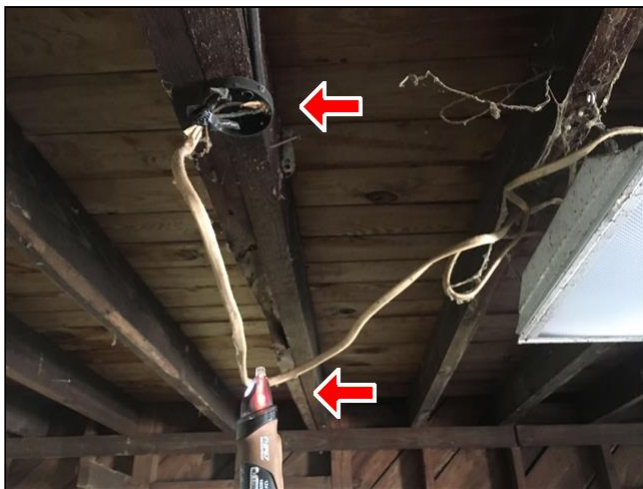
5.6 Item 3(Picture)

(2) Active "hot" wire with no protective junction box in enclosed garage; recommend repair by licensed electrician- this is a safety hazard

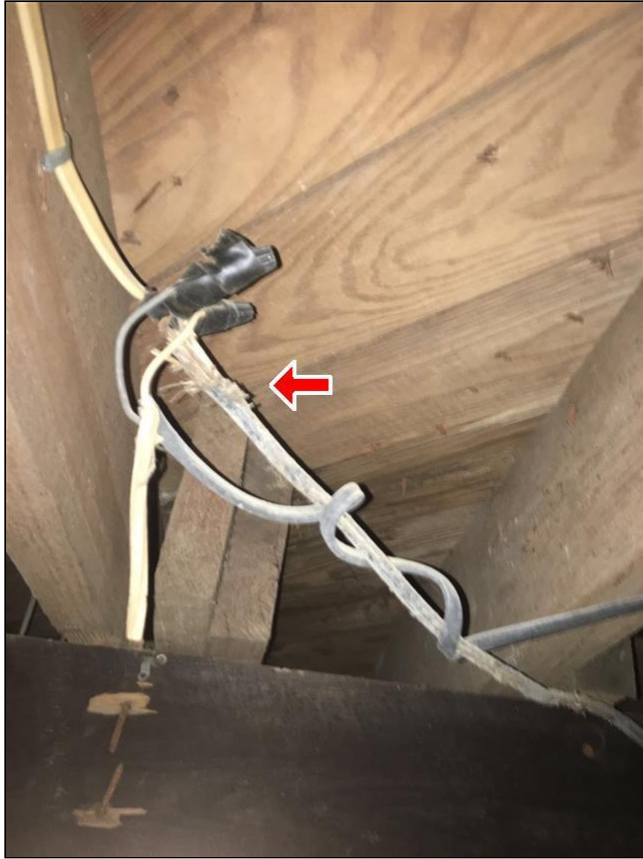
5.6 Item 4(Picture)

(3) Amateur wiring in crawlspace; recommend installation of junction box by qualified electrician

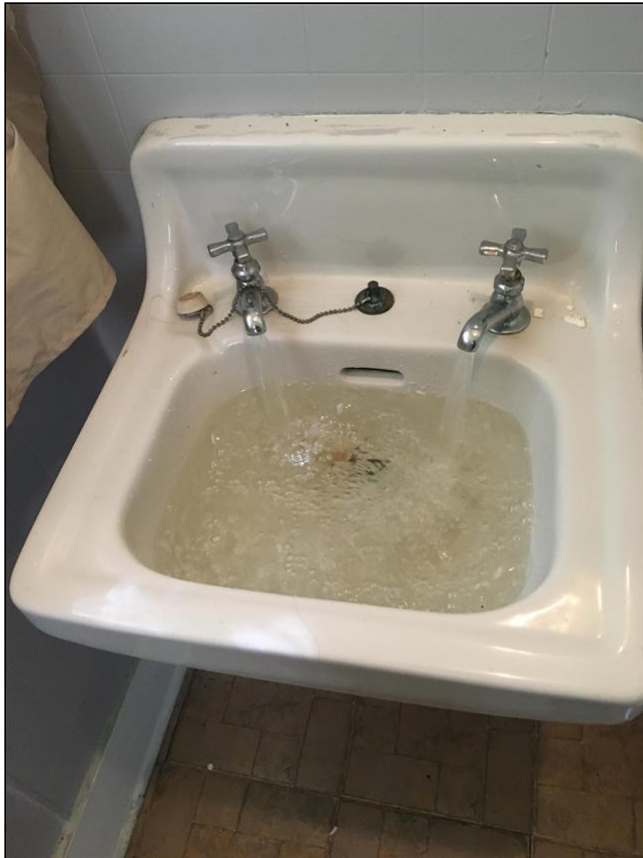
6.6 Item 1(Picture)

Sink in master half bath draining slow; recommend repair using a budget friendly method first i.e. drain "snake" or chemical drain cleaner. If this does not work, recommend evaluation by a professional plumber.

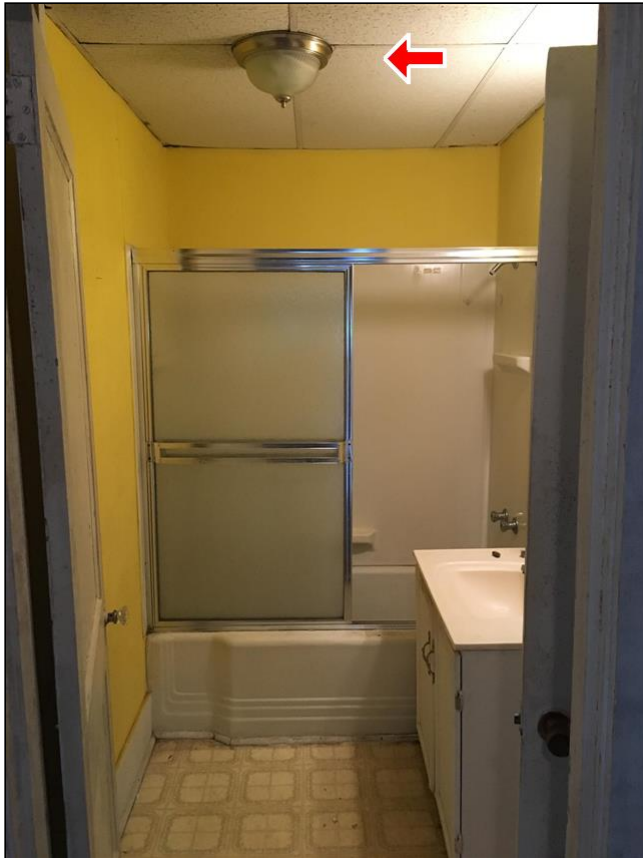
6.8 Item 1(Picture)

(2) Light fixture in hall bath did not work; recommend testing with new light bulb; repair if necessary

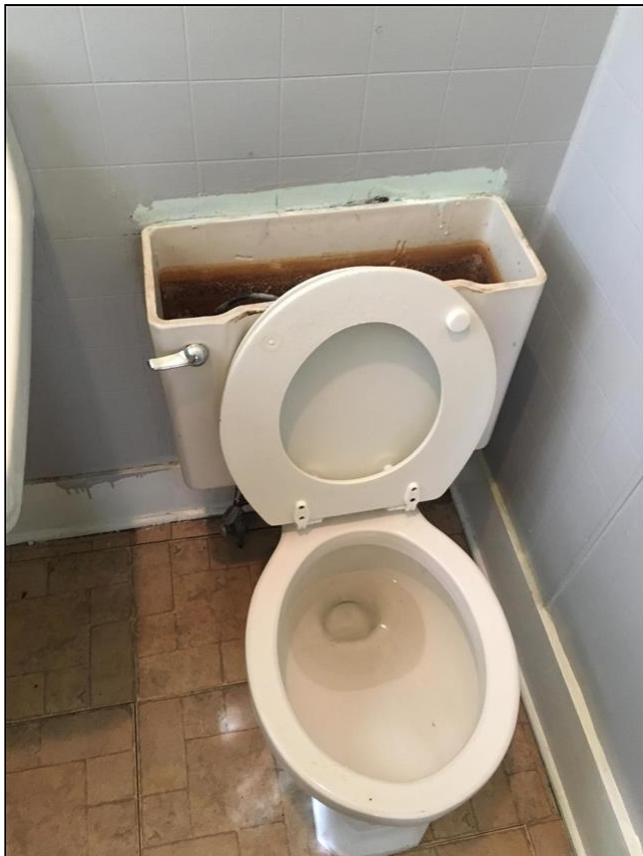
6.8 Item 2(Picture)

(3) Toilet in master half bath did not work at time of inspection; recommend repair or replace

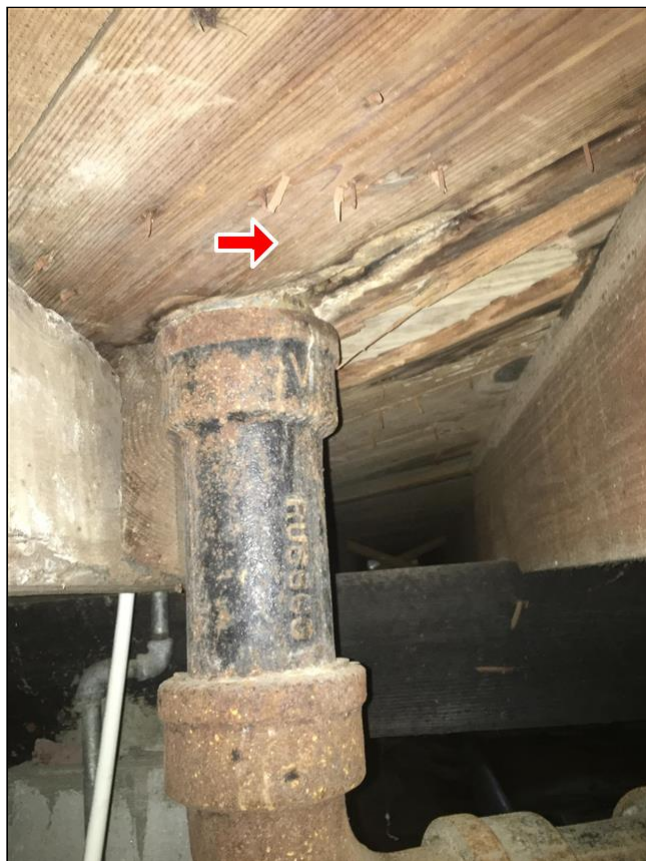
7.3 Item 1(Picture)

Damaged subfloor near pipe entry; recommend repair by qualified contractor

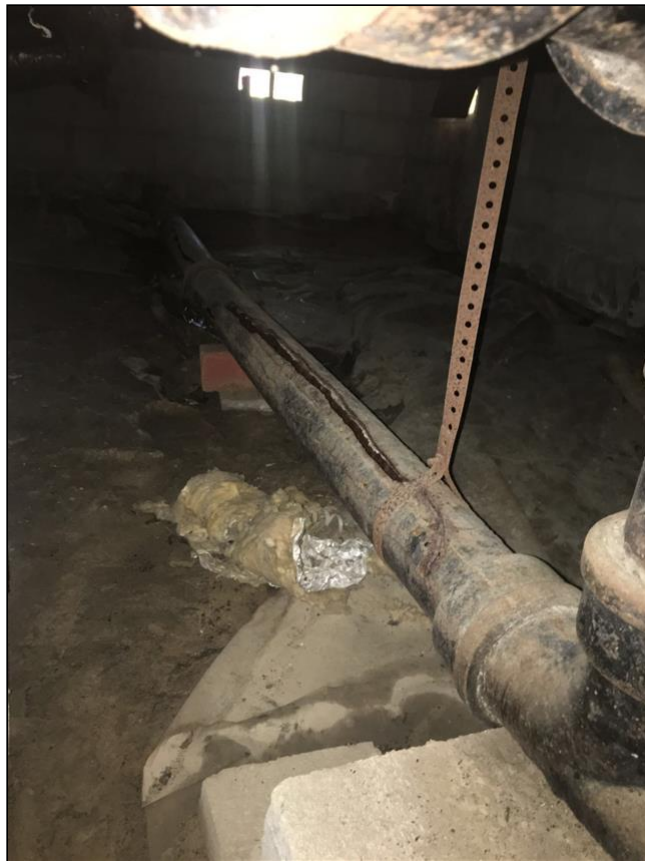
8.0 Item 3(Picture)

**8.0** (1) Video of water leak and damaged cast iron pipes in crawlspace; recommend replacing all damaged pipes by qualified professional plumber

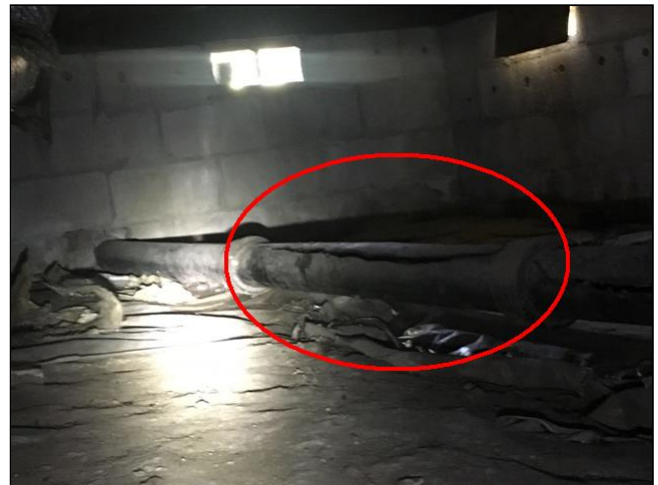
8.0 Item 4(Picture)

(2) Rust present on cast iron pipes; debris present on inside; recommend upgrading plumbing waste system in crawlspace as necessary

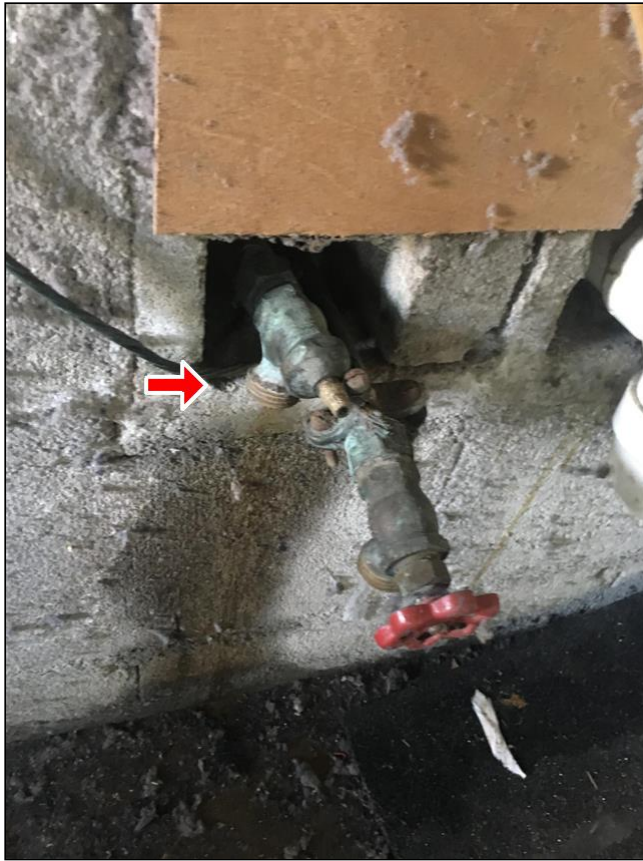
8.1 Item 1(Picture)

Distribution pipes for washer connection missing gate valve; recommend repair or replacement

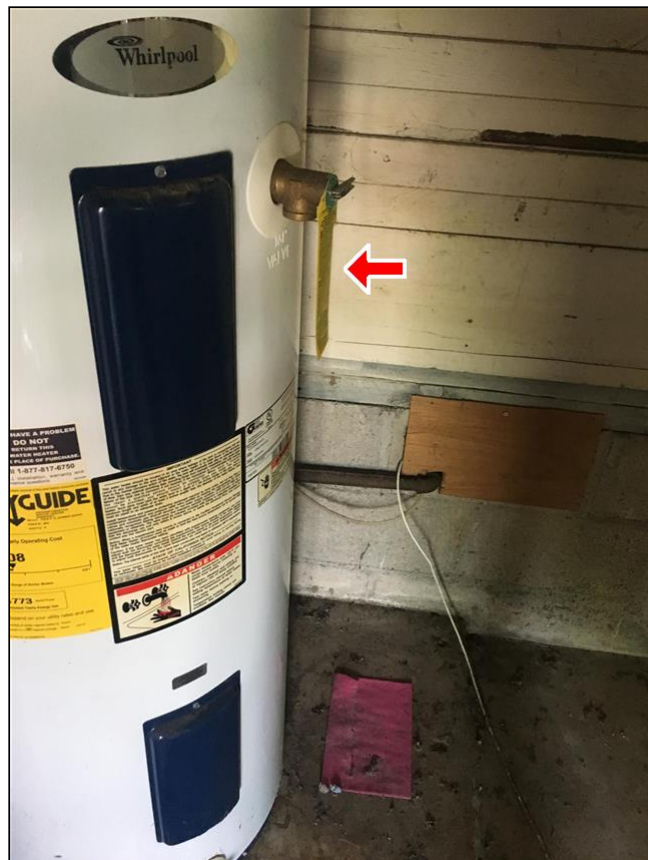
8.2 Item 1(Picture)

The T&P (Test and Pressure) valve on water heater needs a 3/4 threaded pipe to extend within 6 inches of floor for safety. (PVC is not approved for hot water use). I recommend repair by a qualified person.

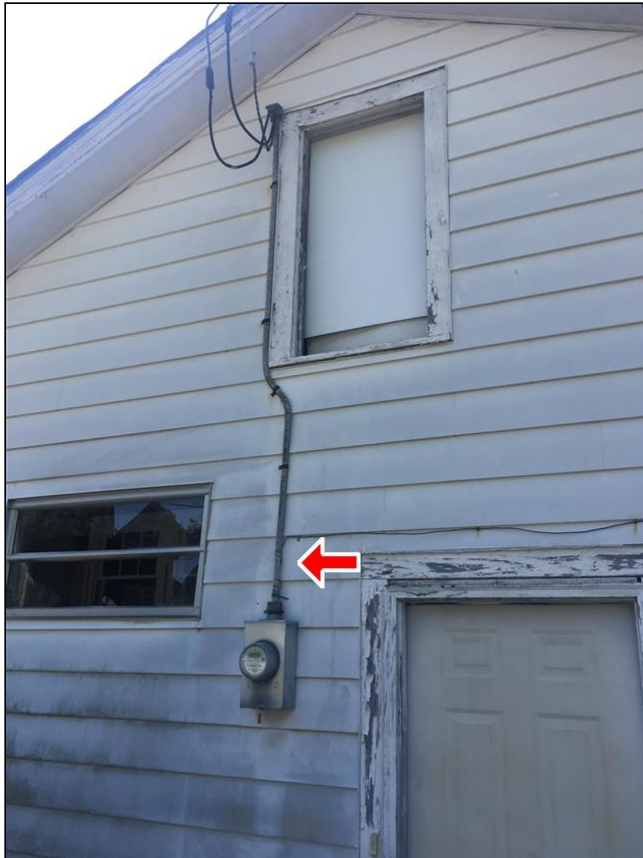
9.0 Item 1(Picture)

The electrical service conductors are frayed at wire sheathing outside and needs repair or replace.

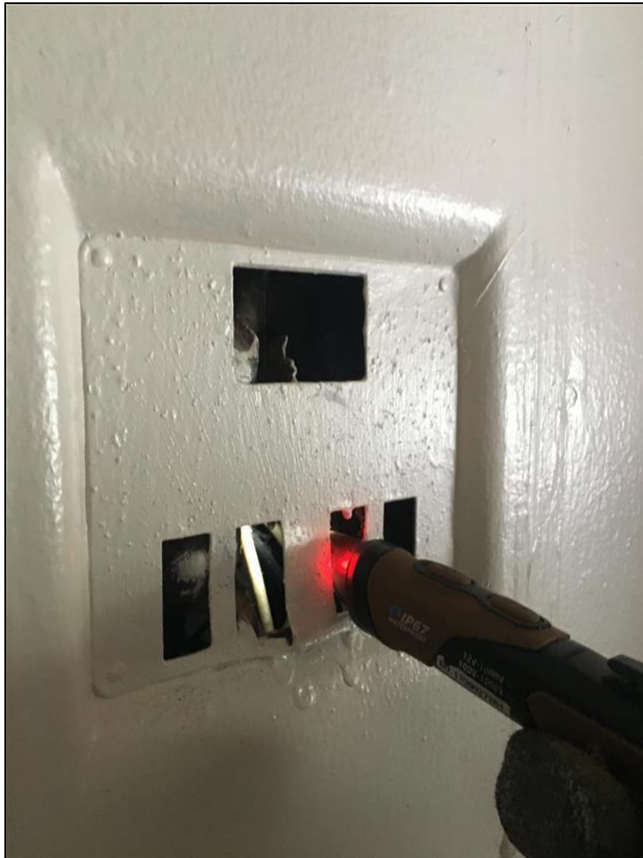
9.1 Item 1(Picture)

(1) Electric subpanel in kitchen missing areas of protective covering; tester shows active "hot" wires easily accessible; recommend repair by licensed electrician - safety hazard

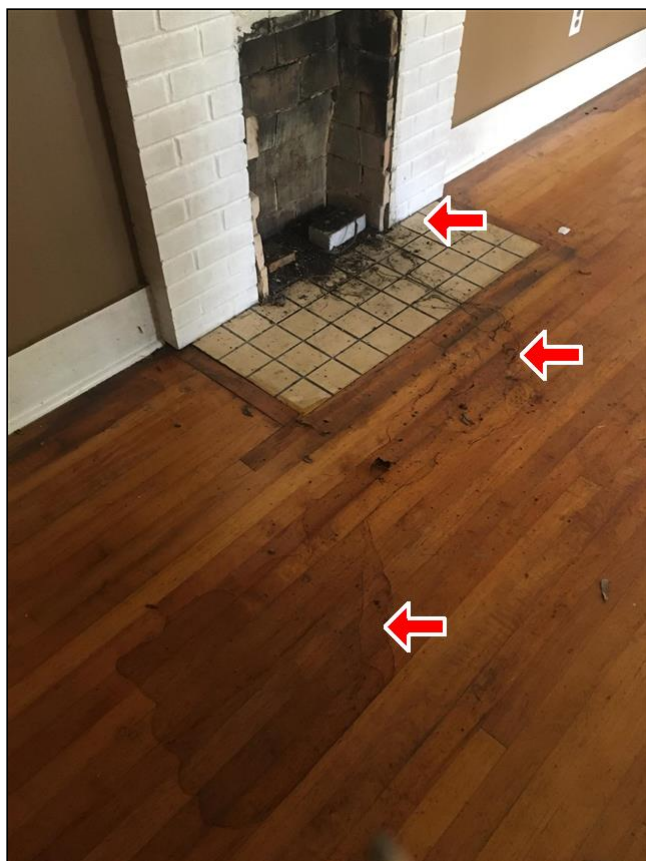
10.6 Item 1(Picture)

Apparent moisture stain starting from fire box moving onto flooring; recommend qualified contactor evaluate and repair any leaks as necessary
